Catherine Anderson  
~~0124~~ 963454

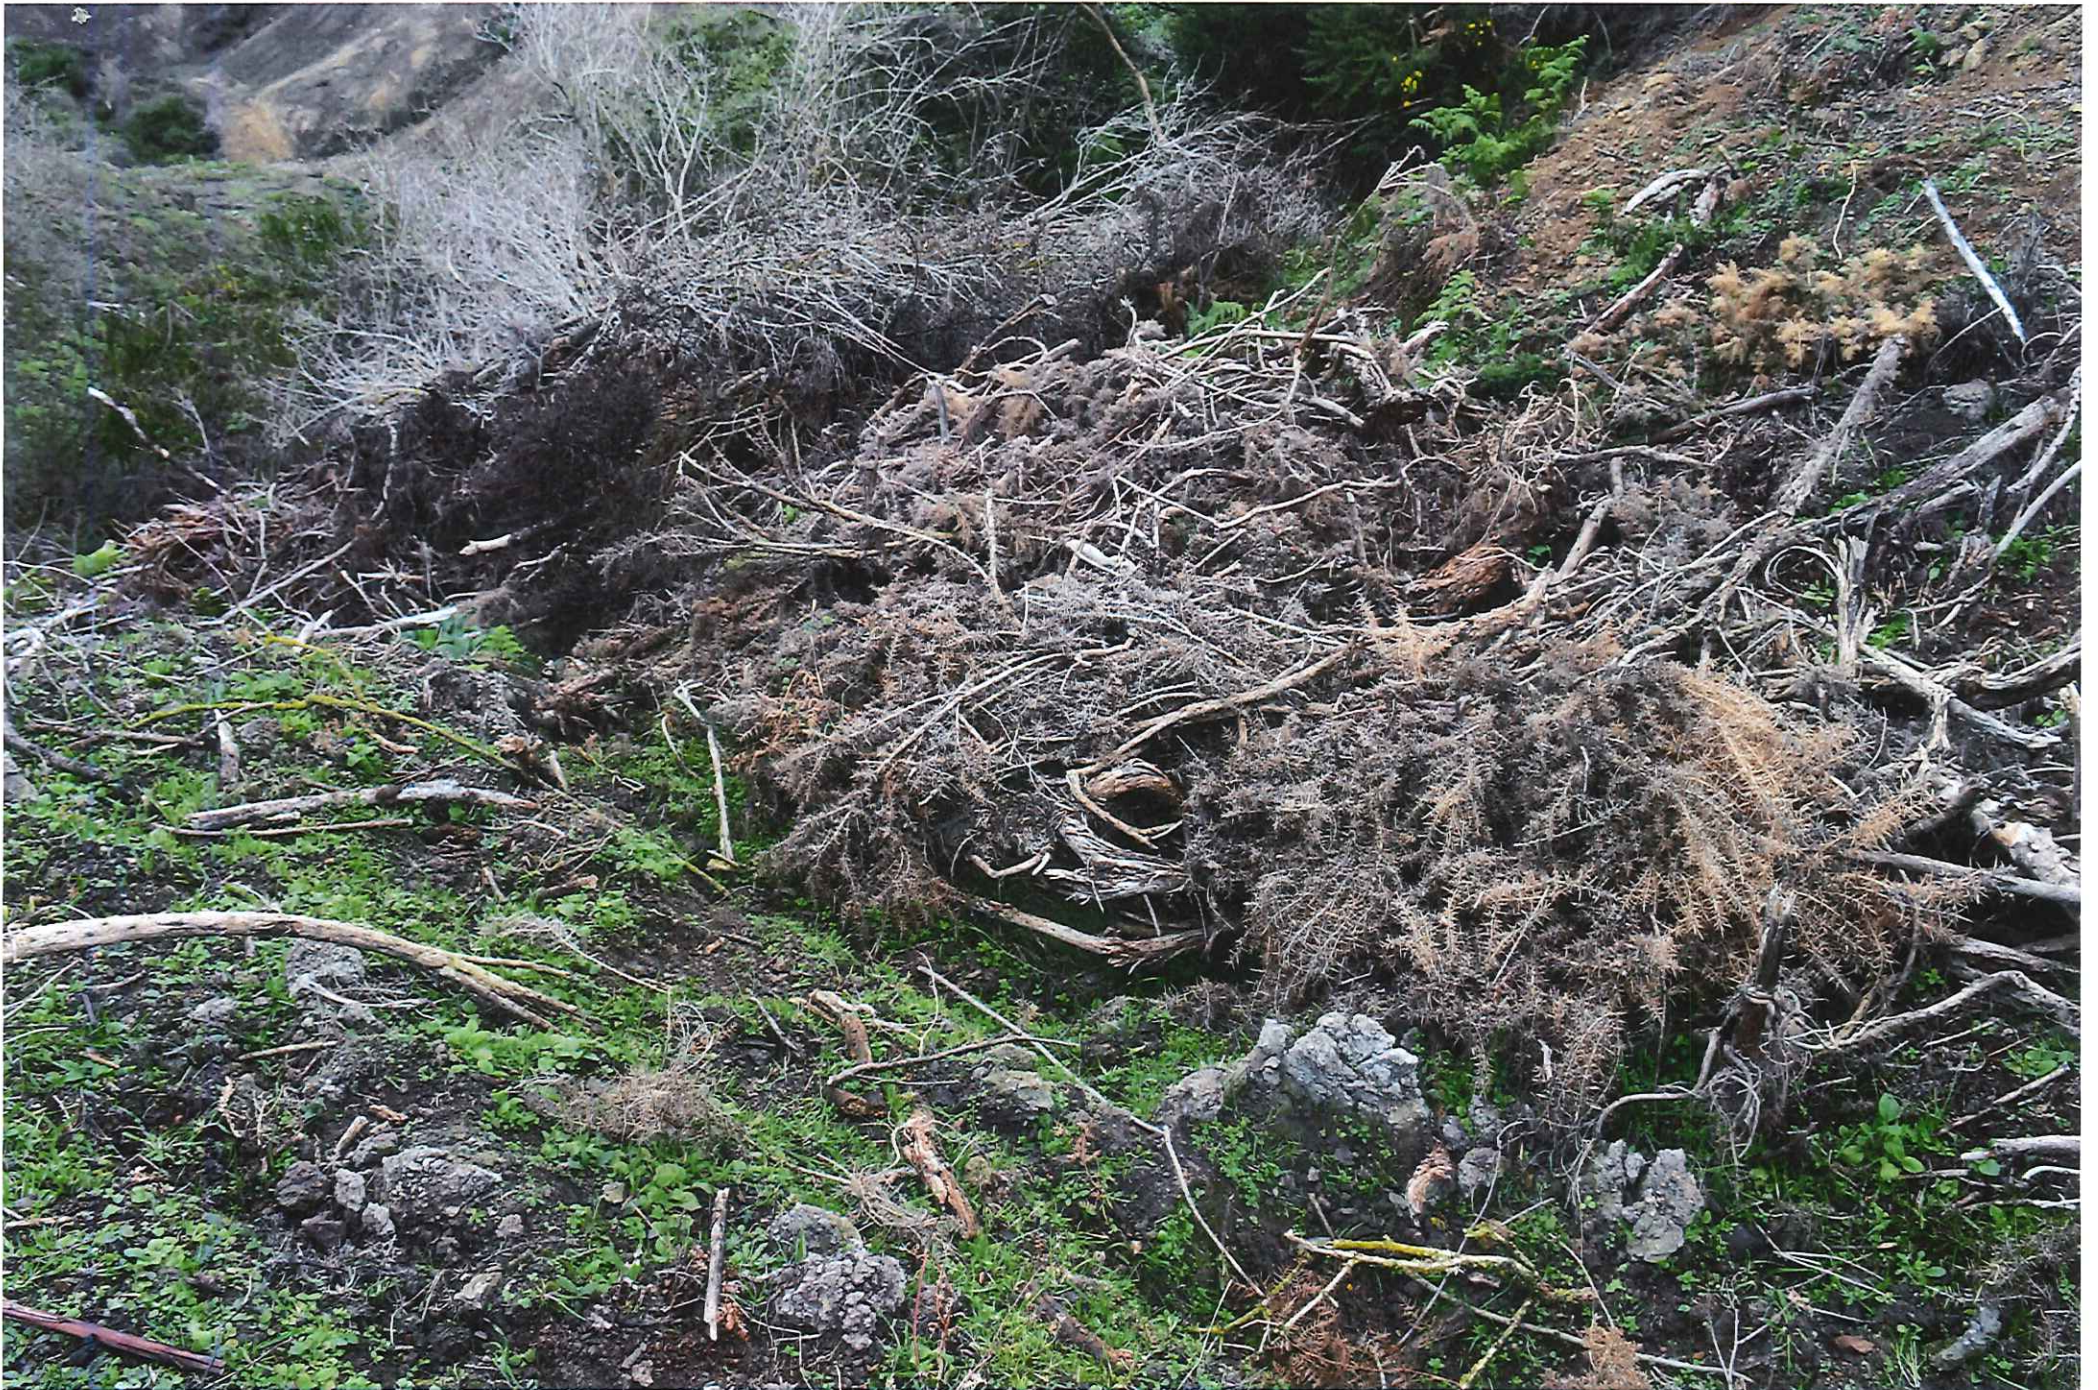
Waterway

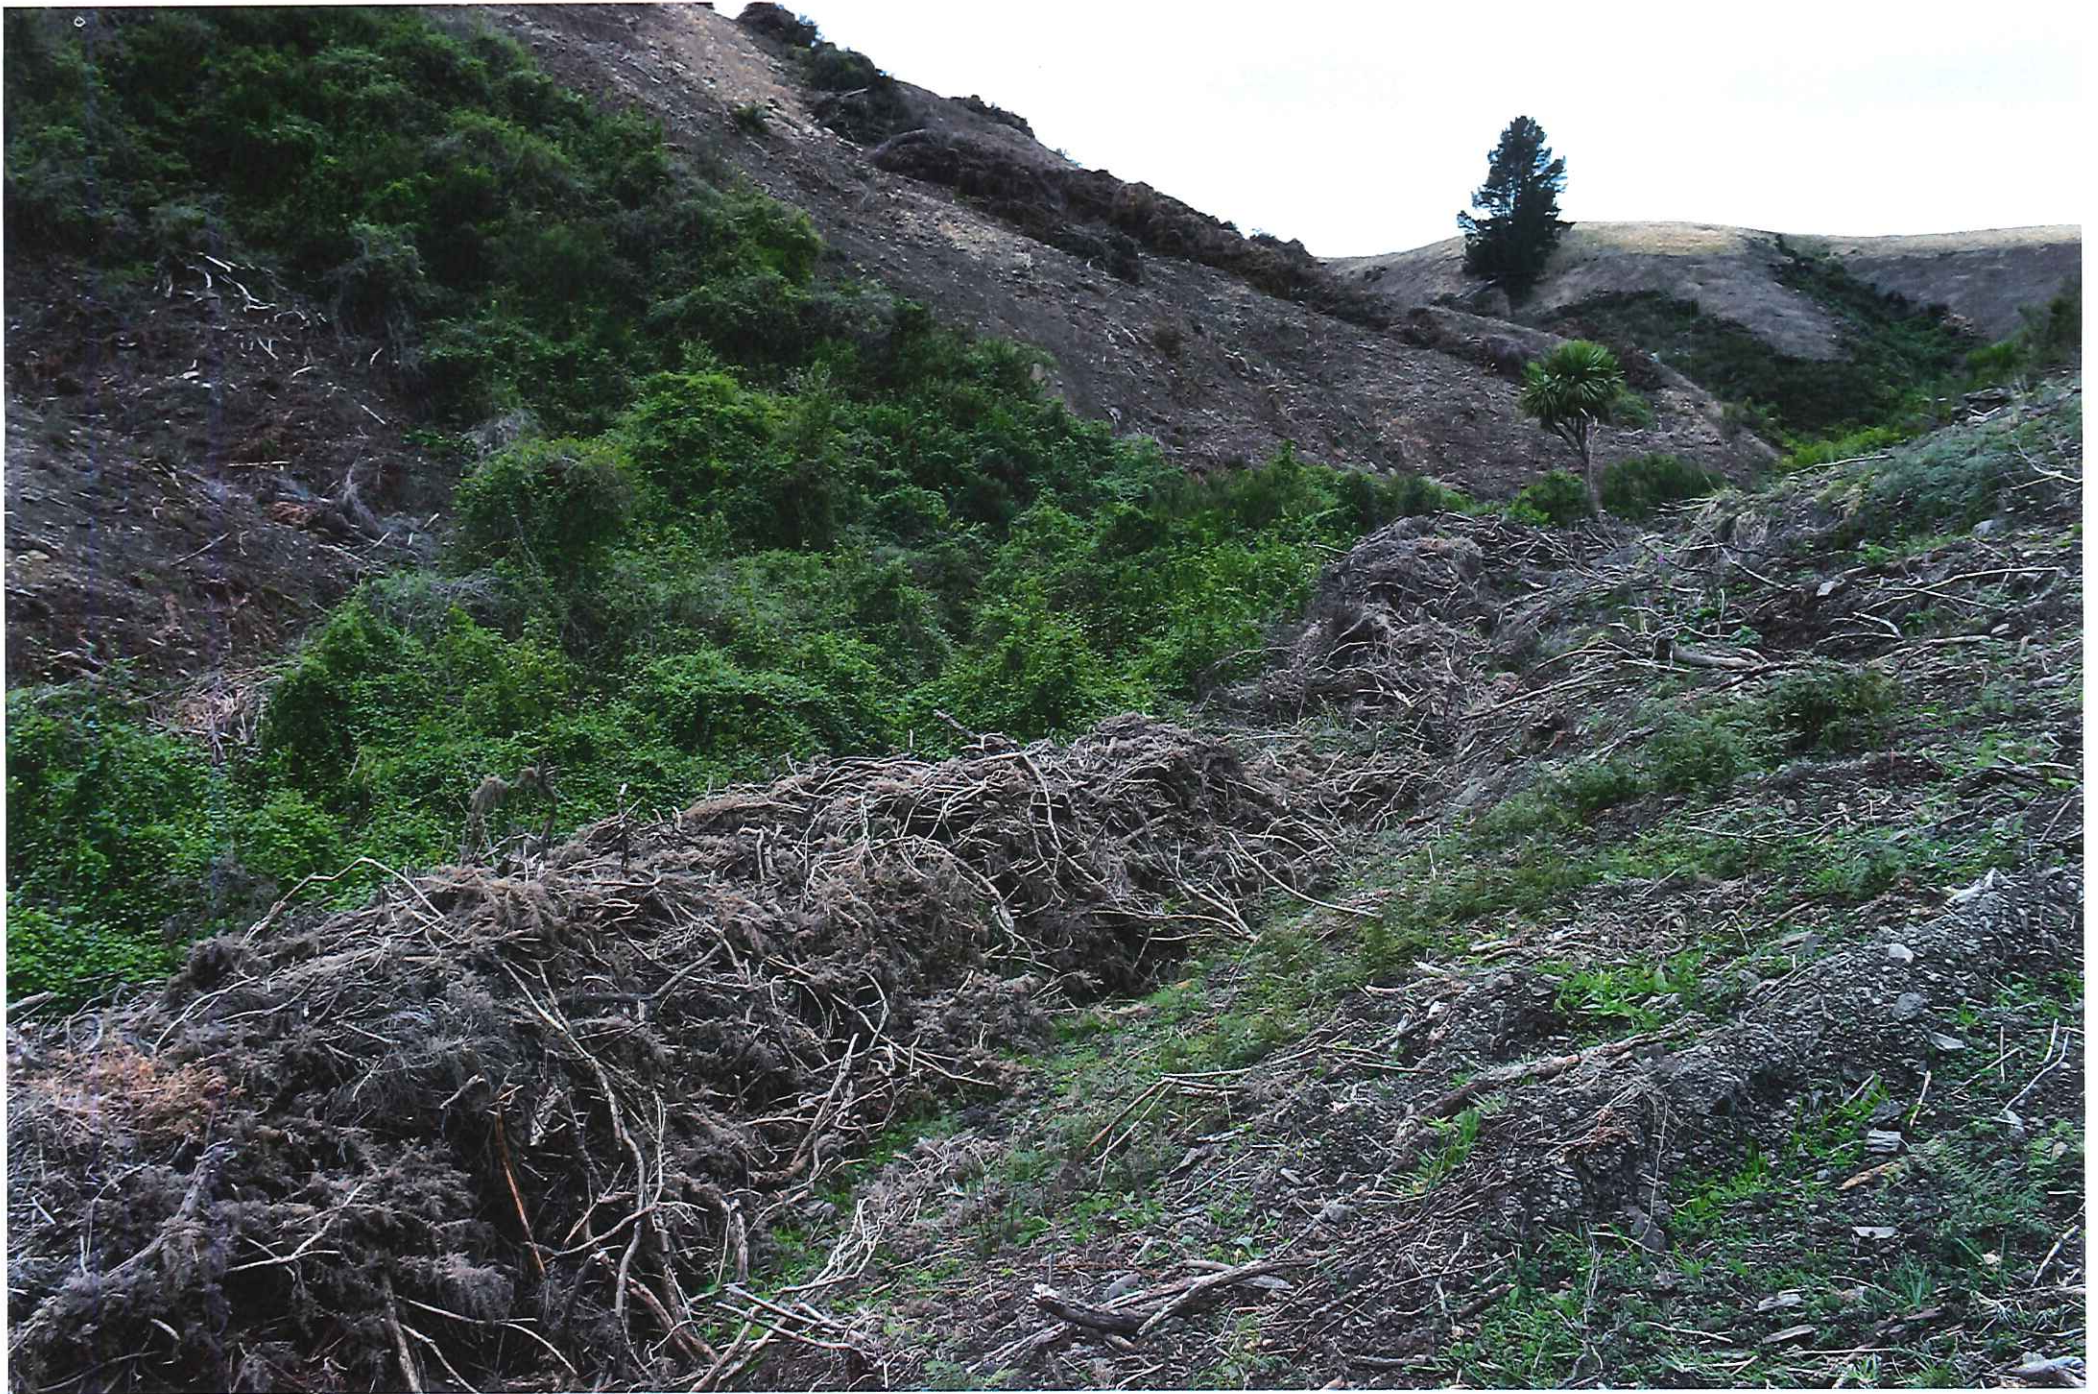
Creek with water races underneath

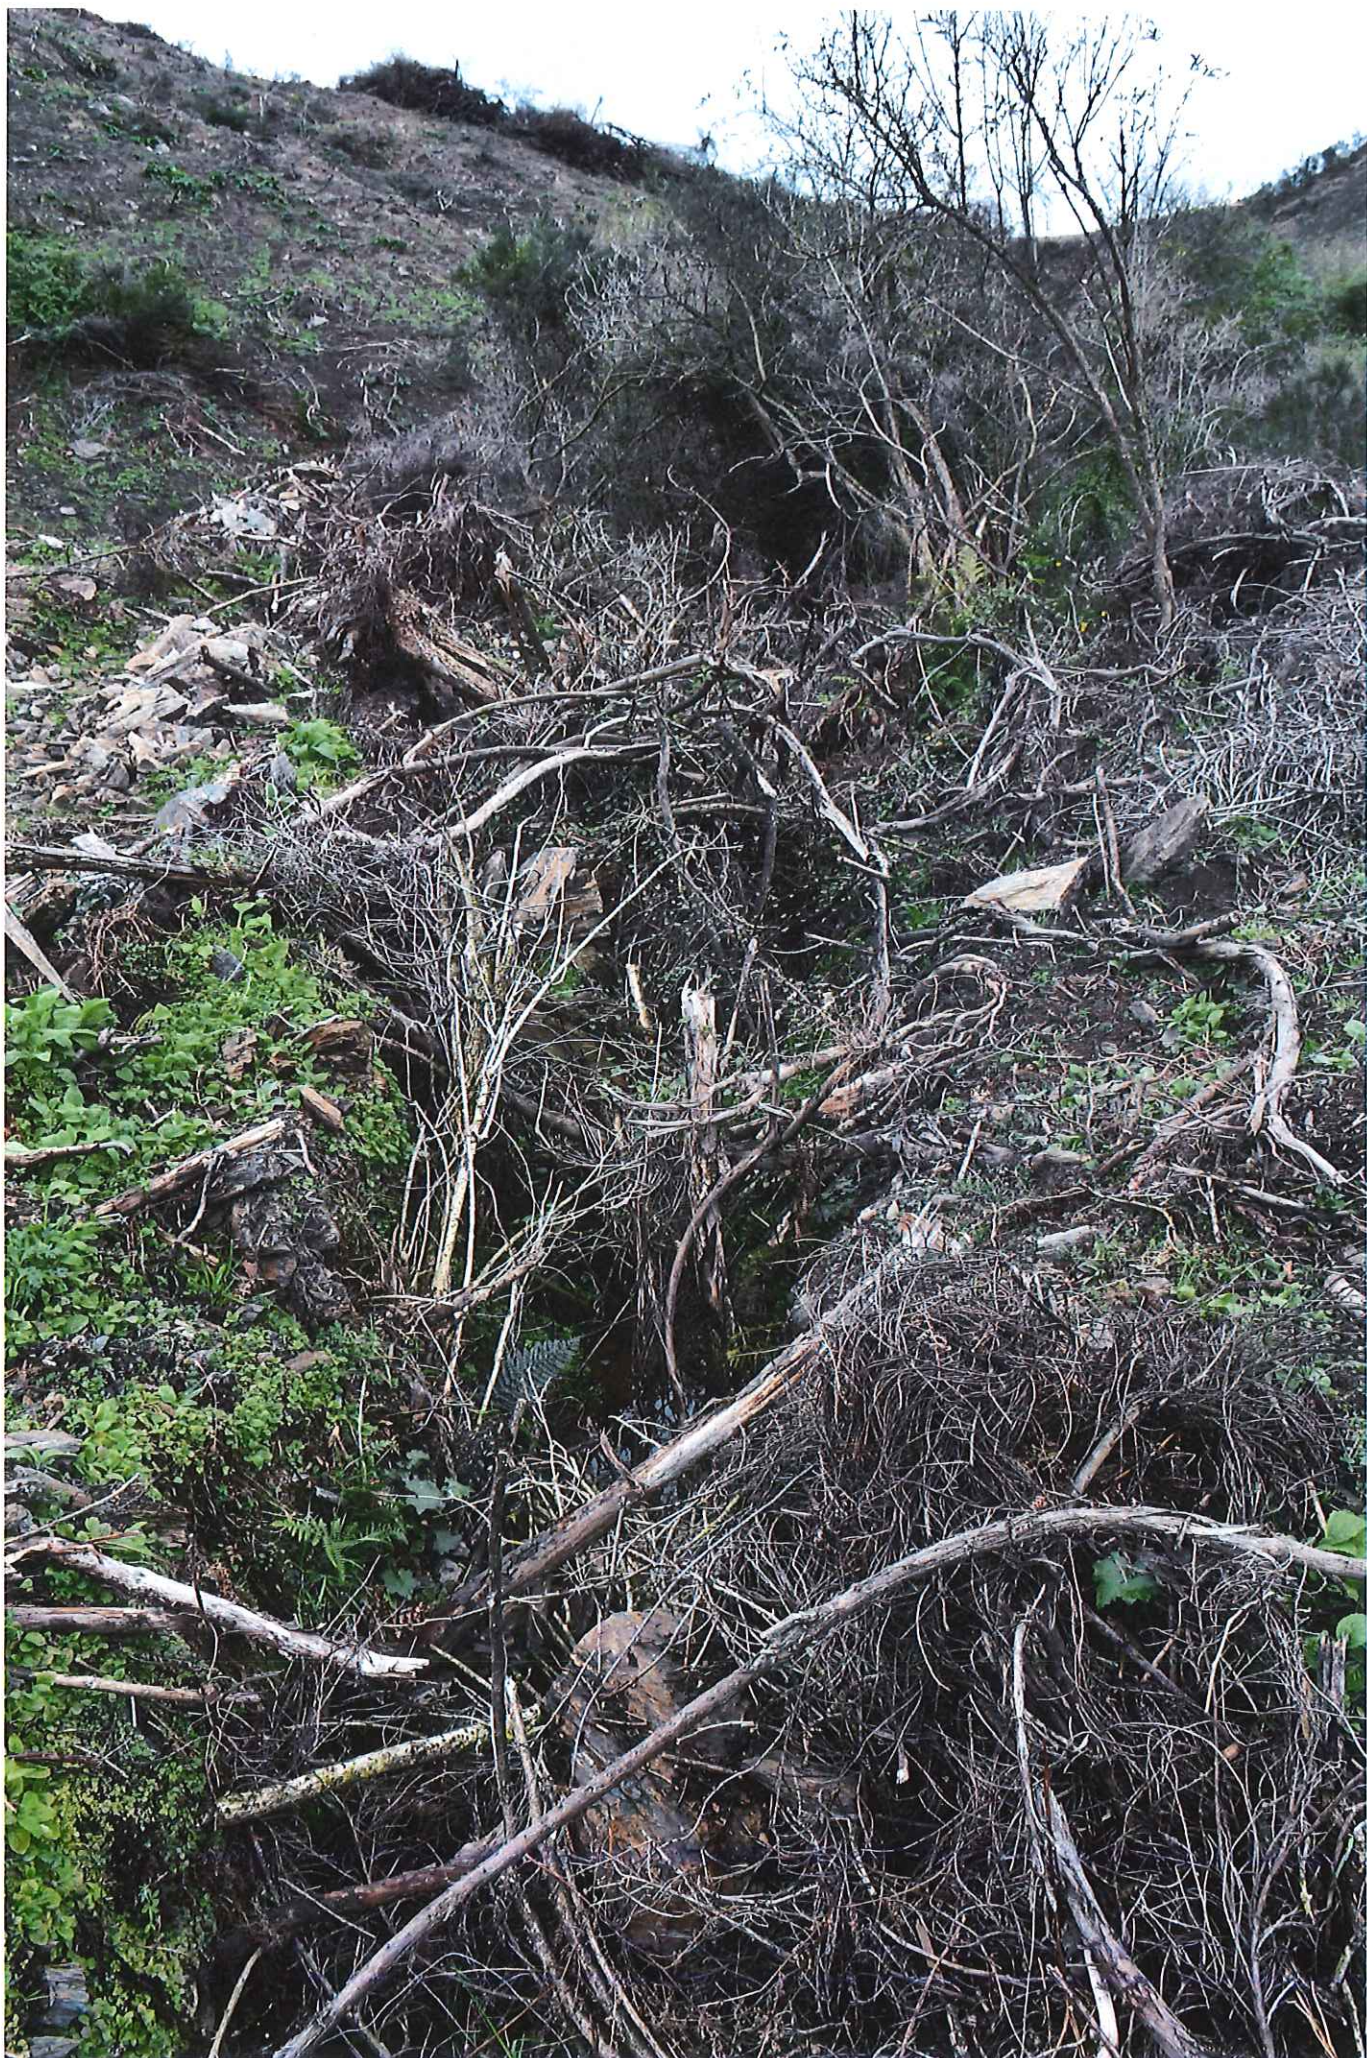
Mine entrance and stream underneath

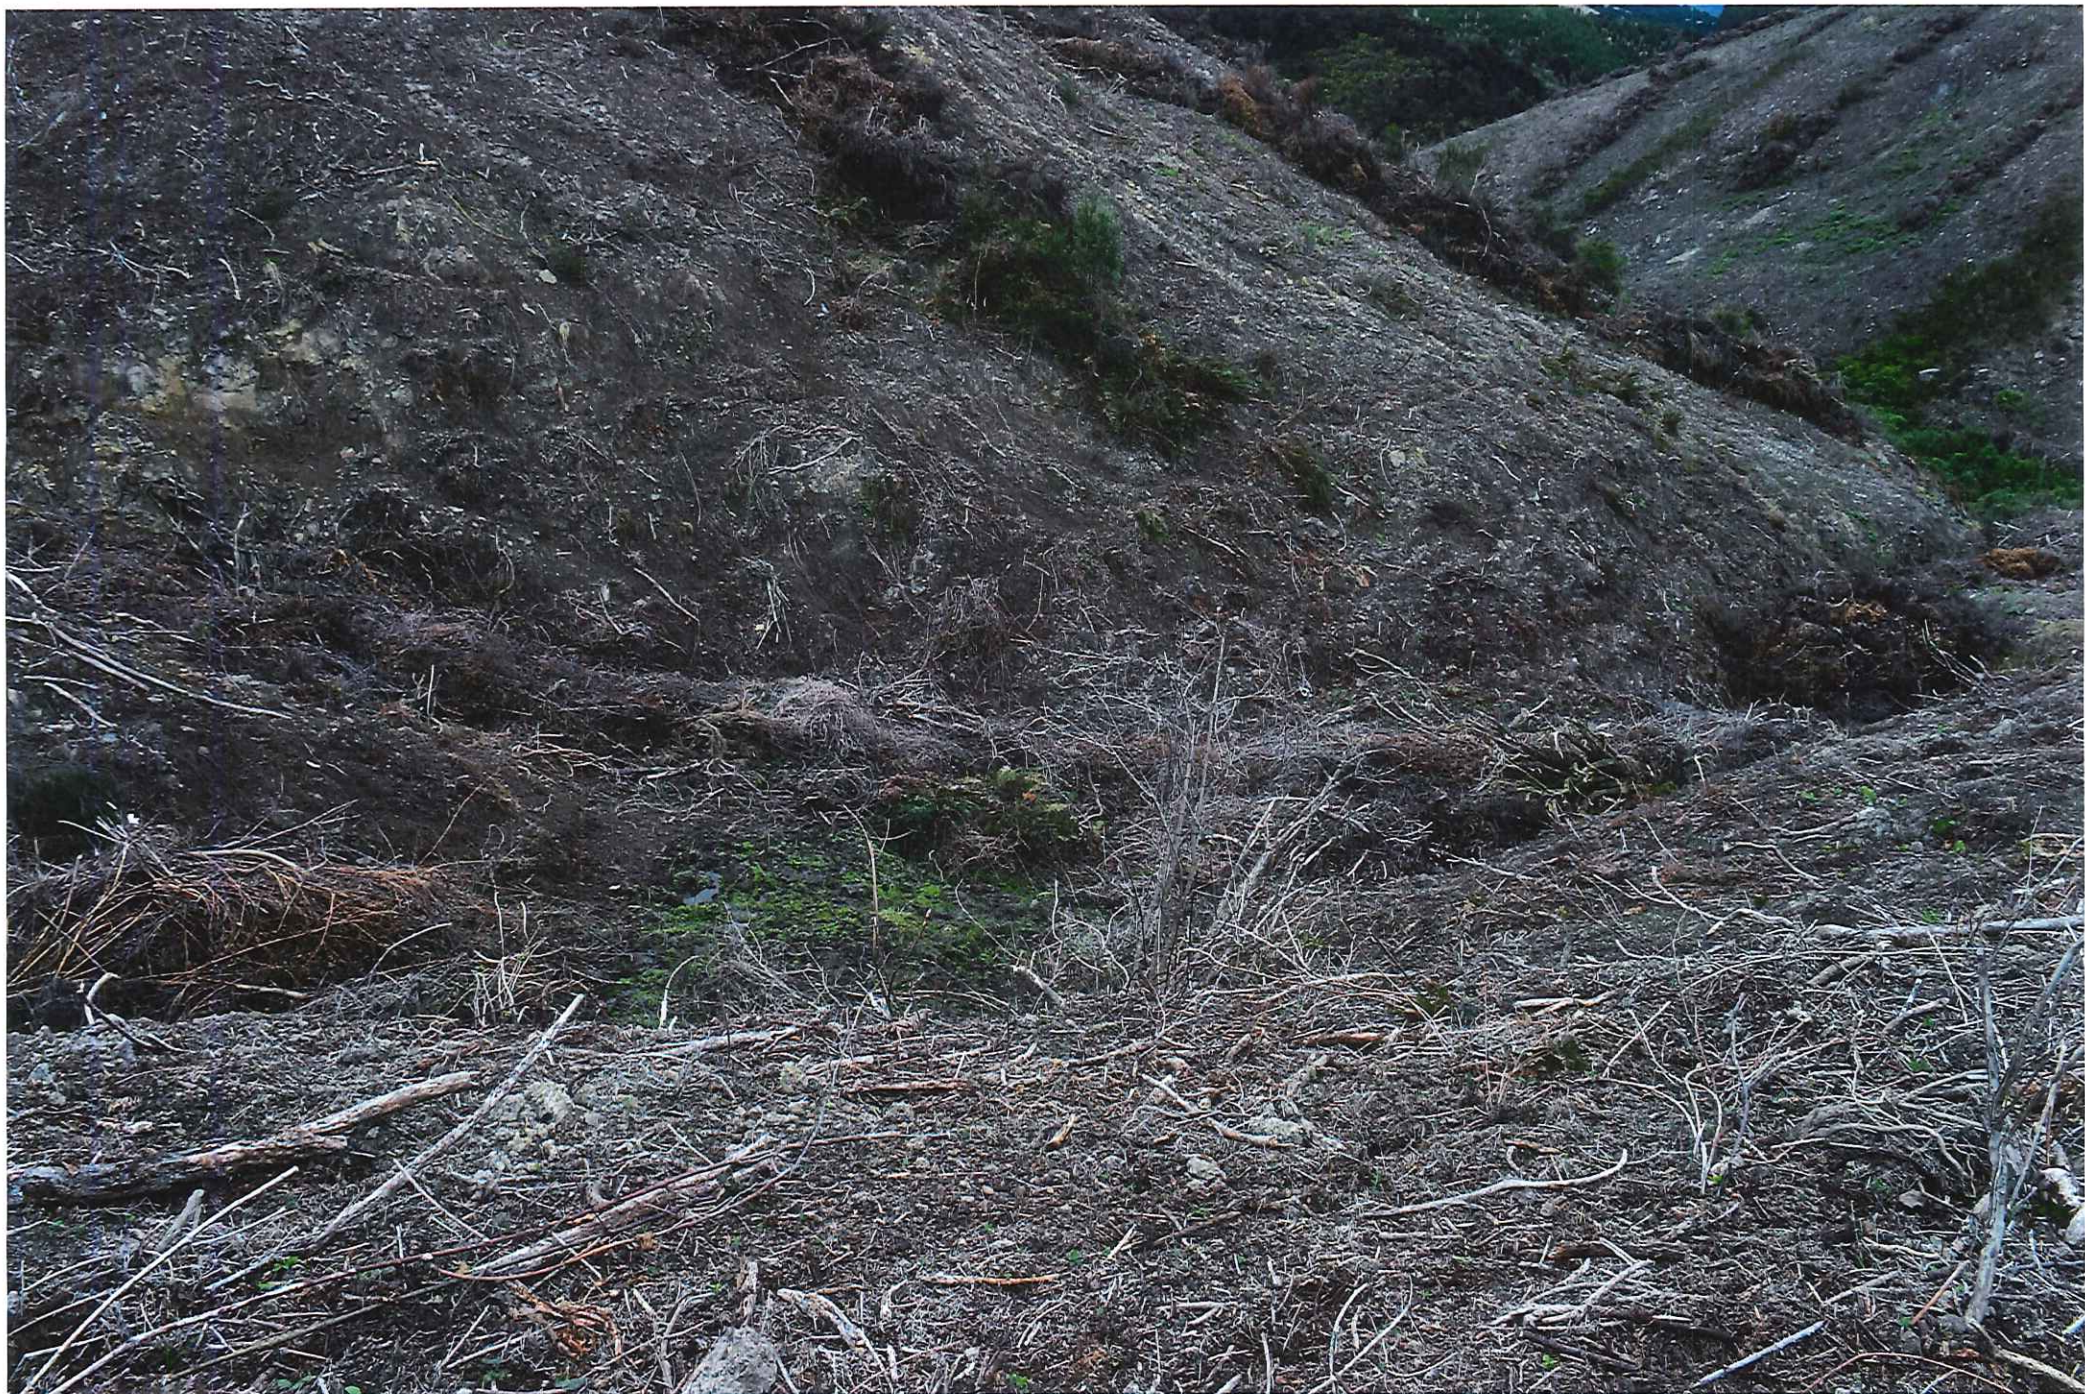
Water way

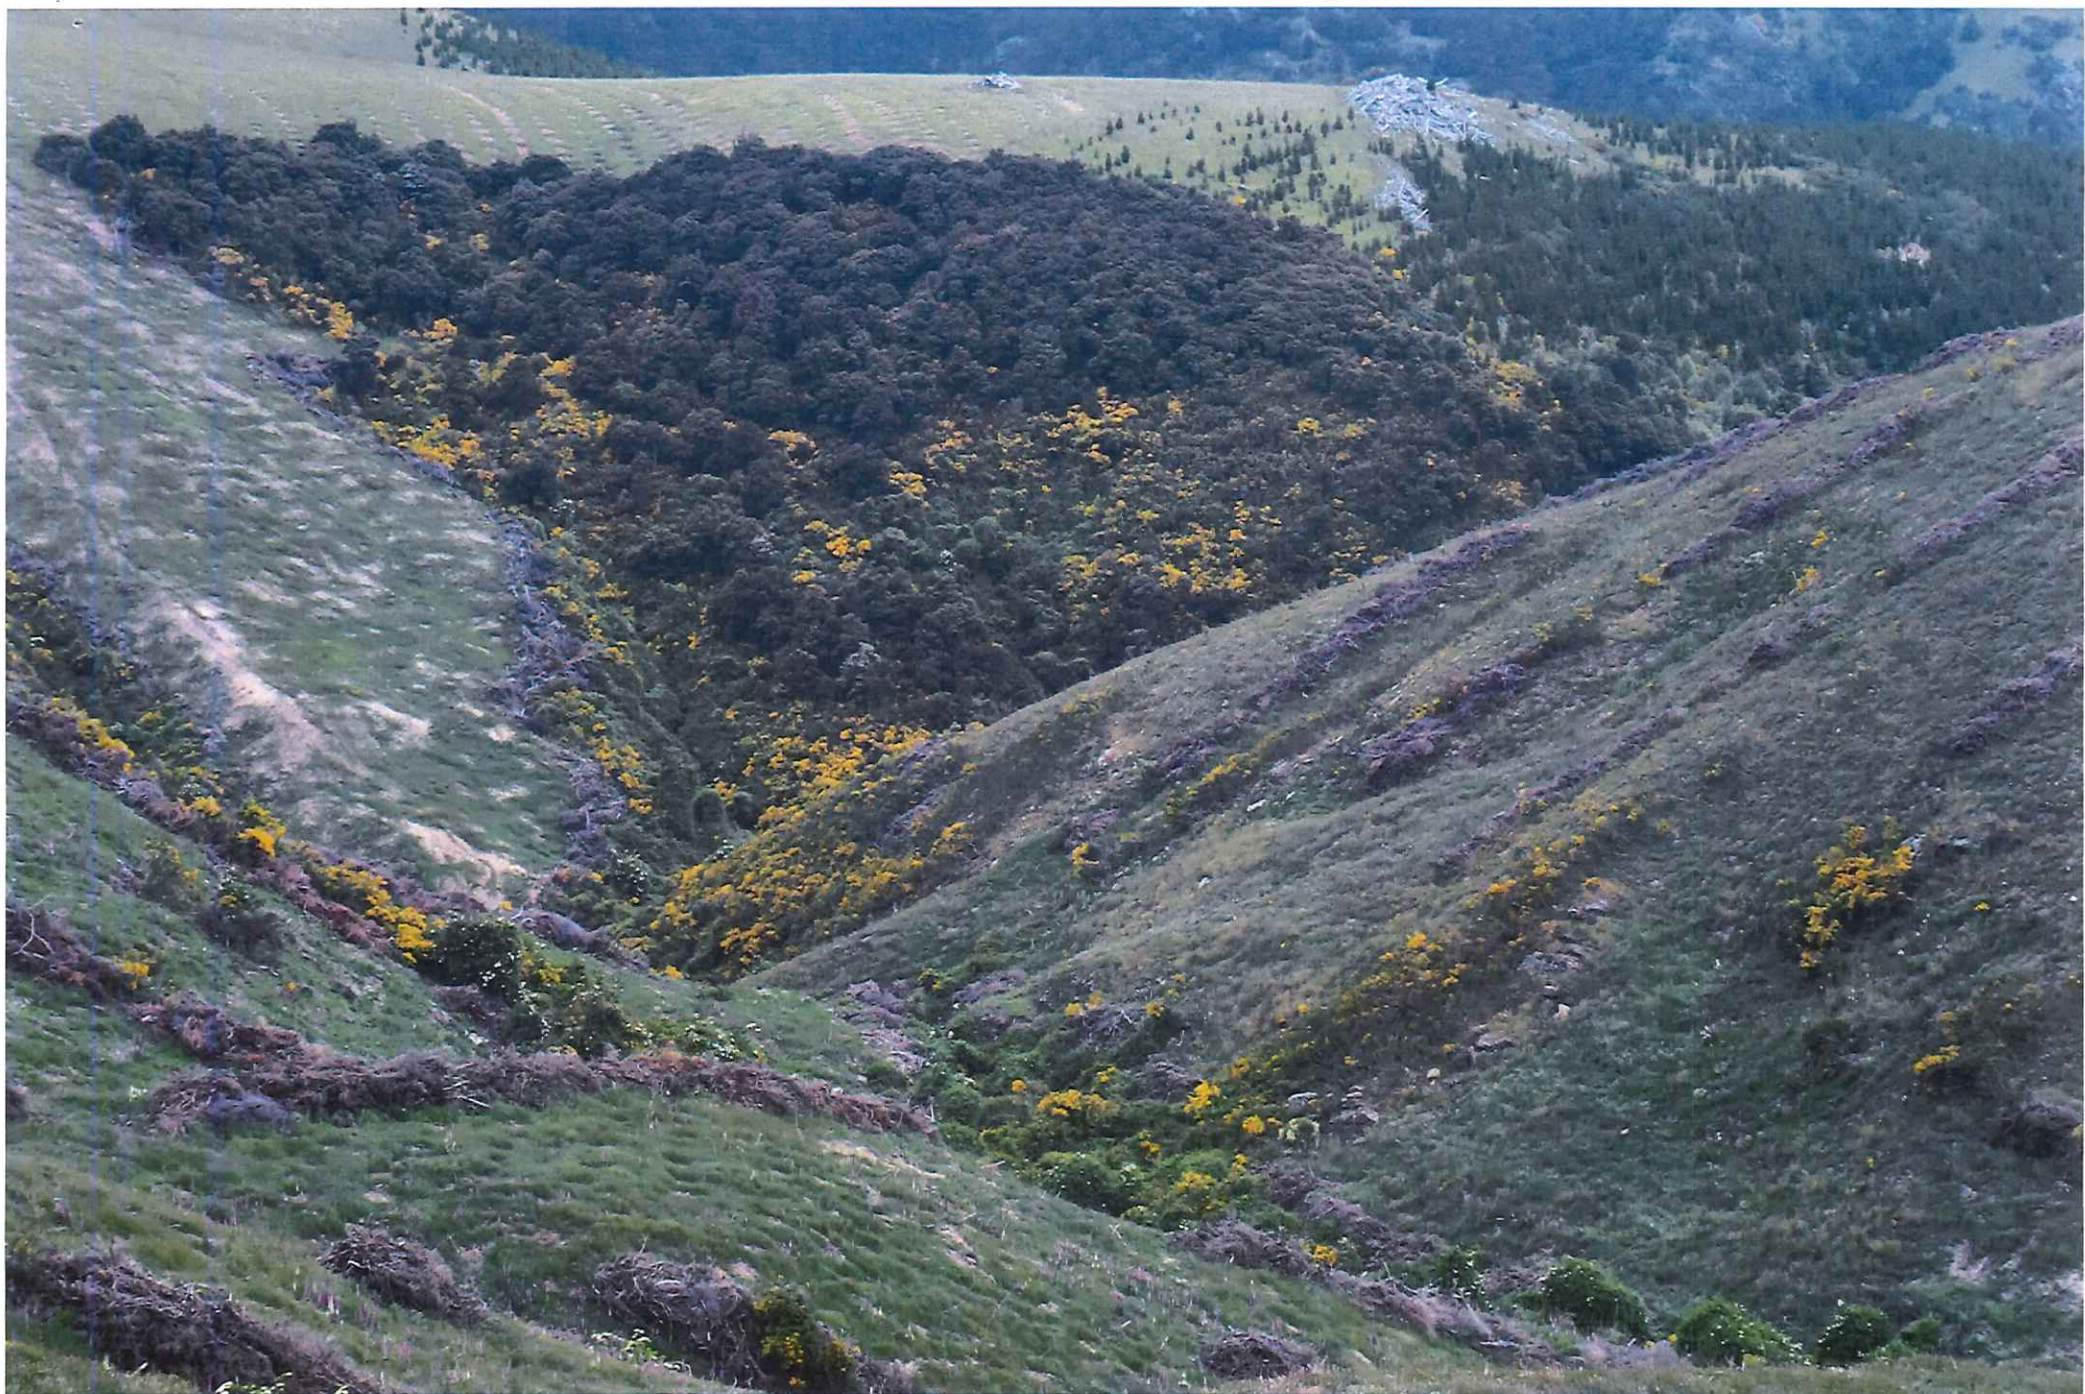
Growing over bulldozing

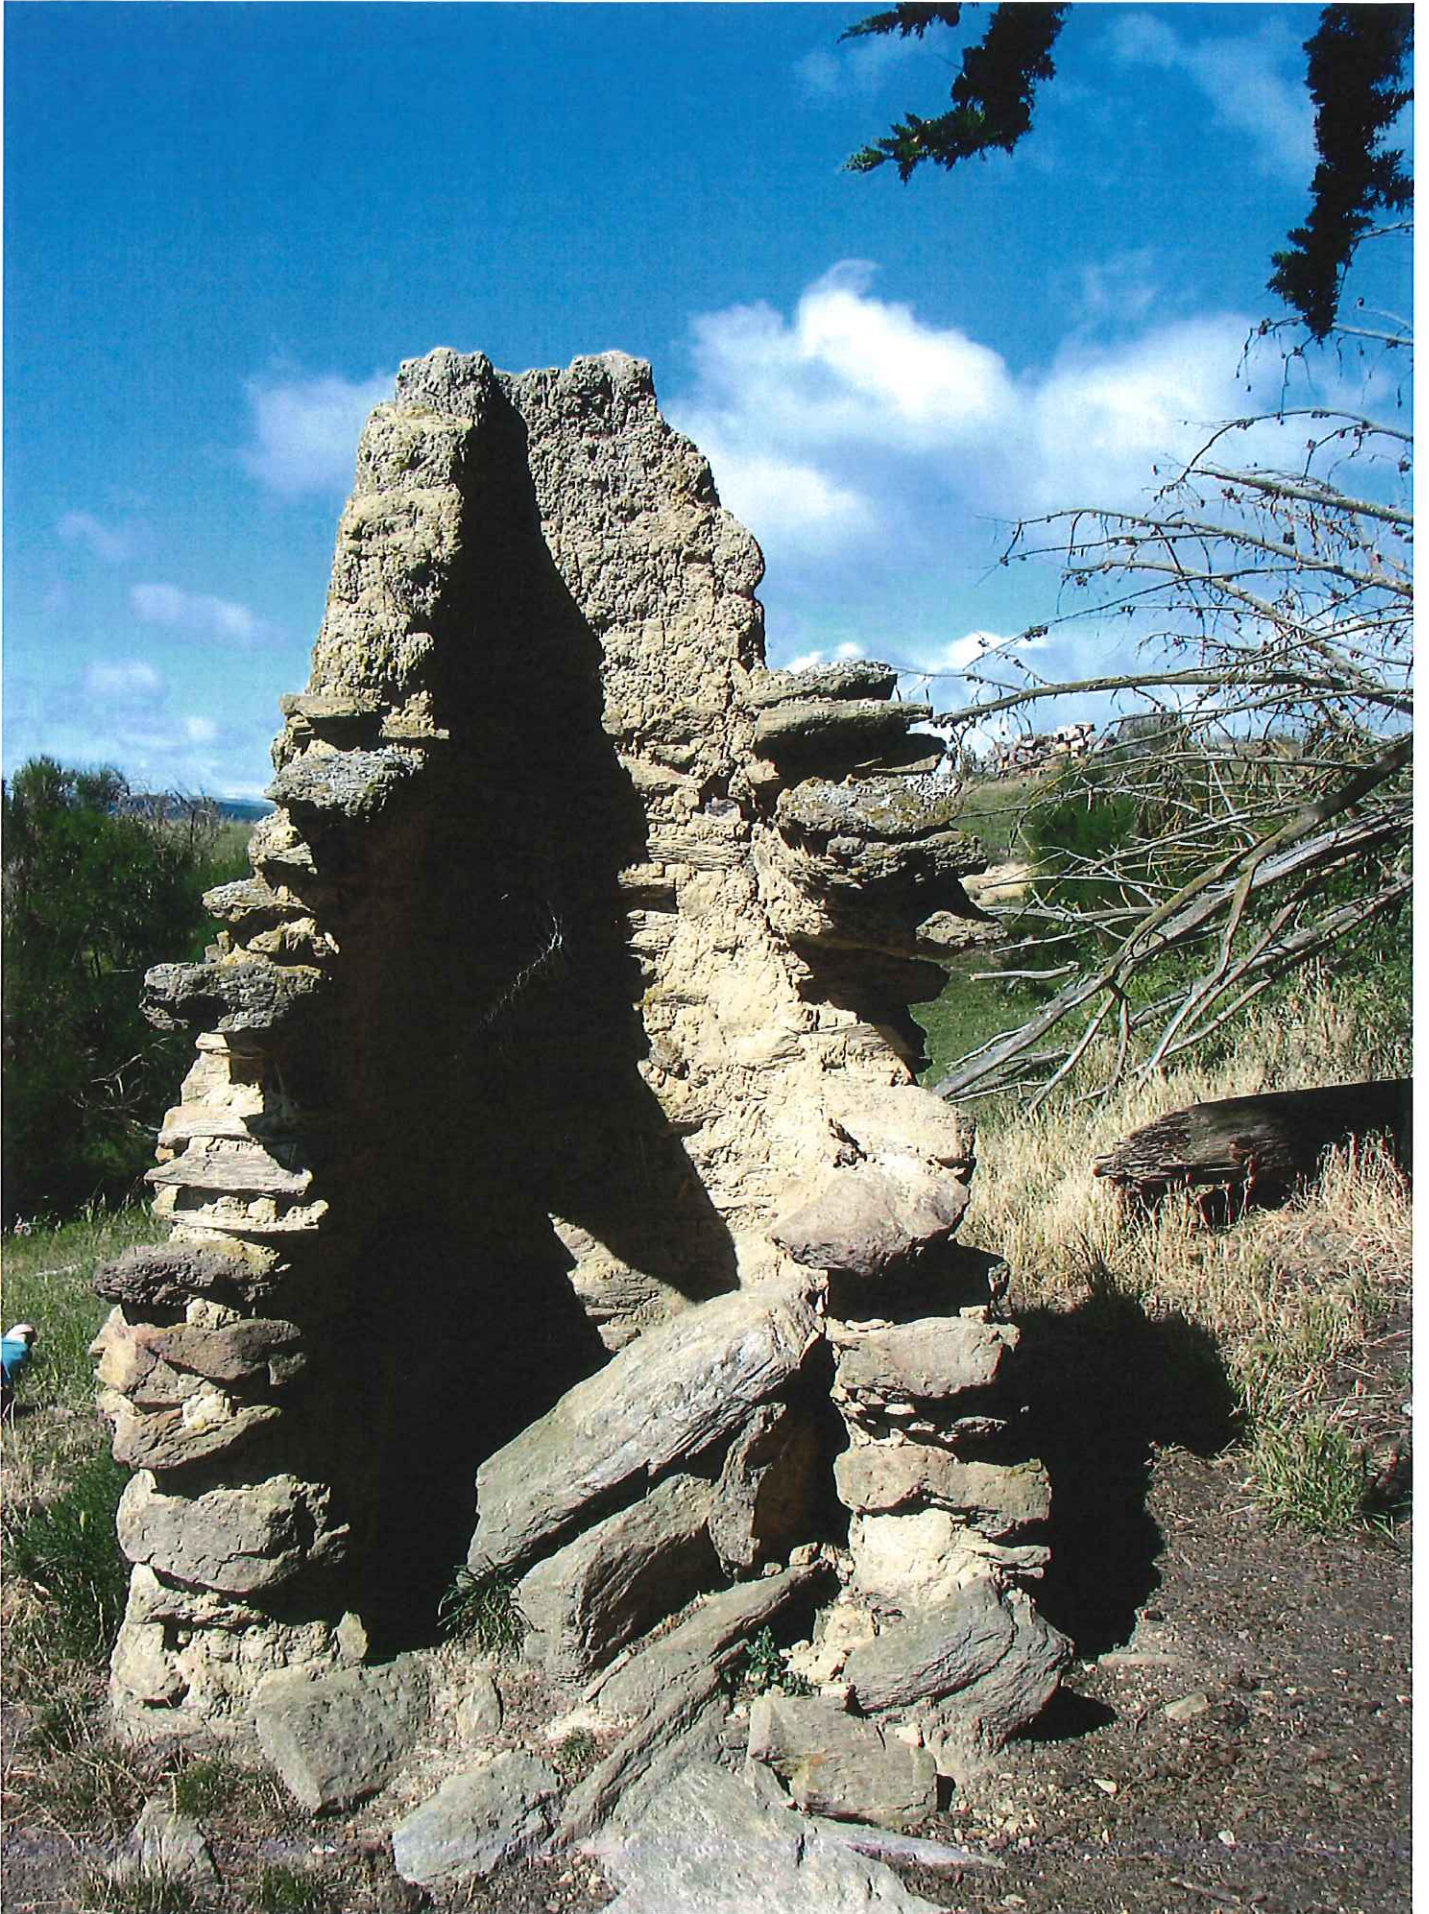
*This has been bulldozed*

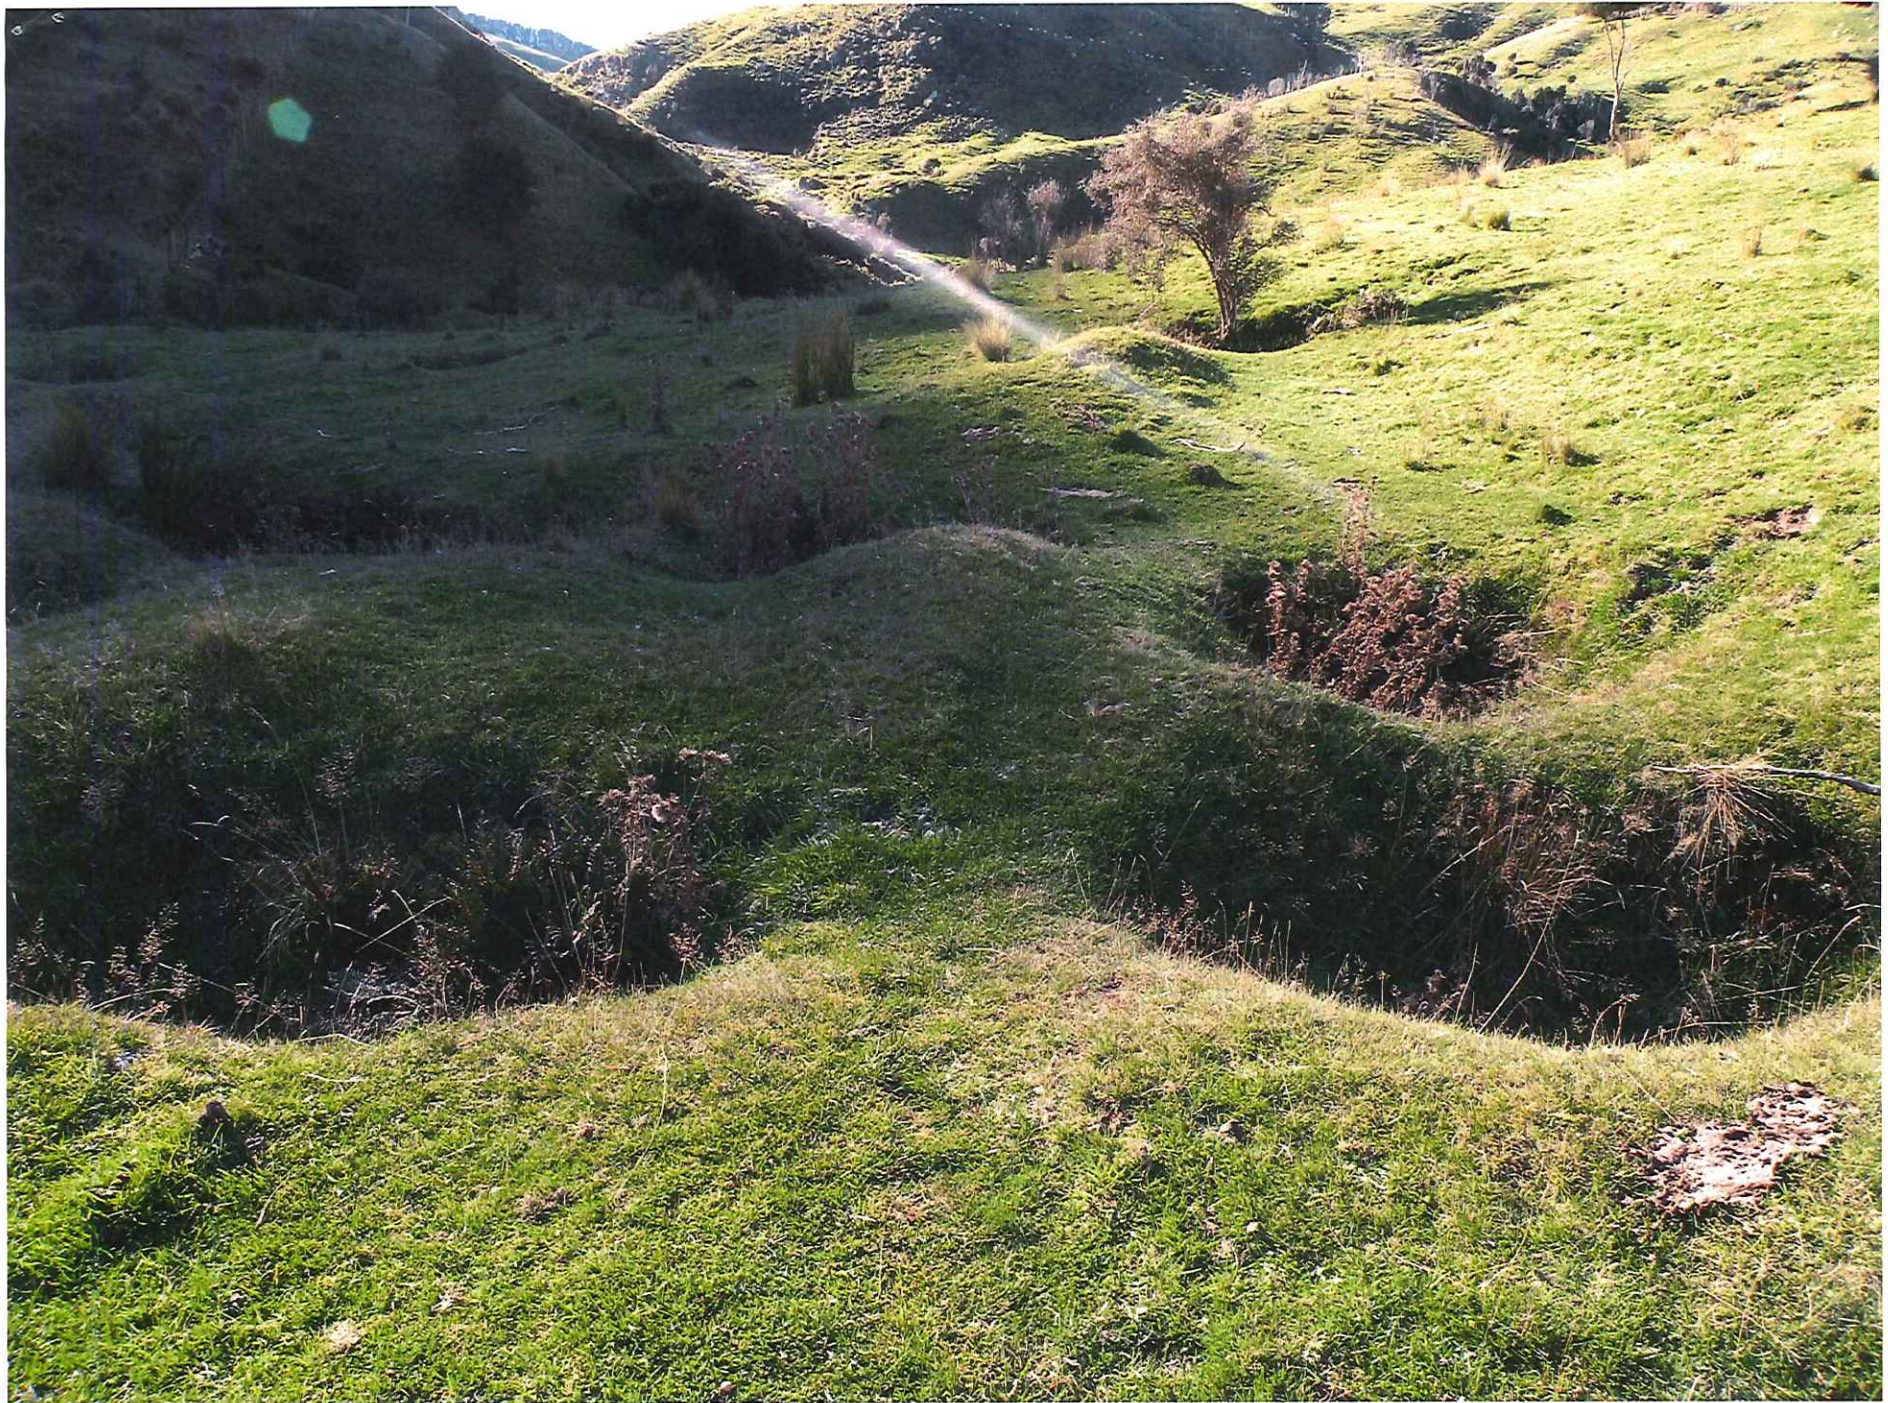
Mining site

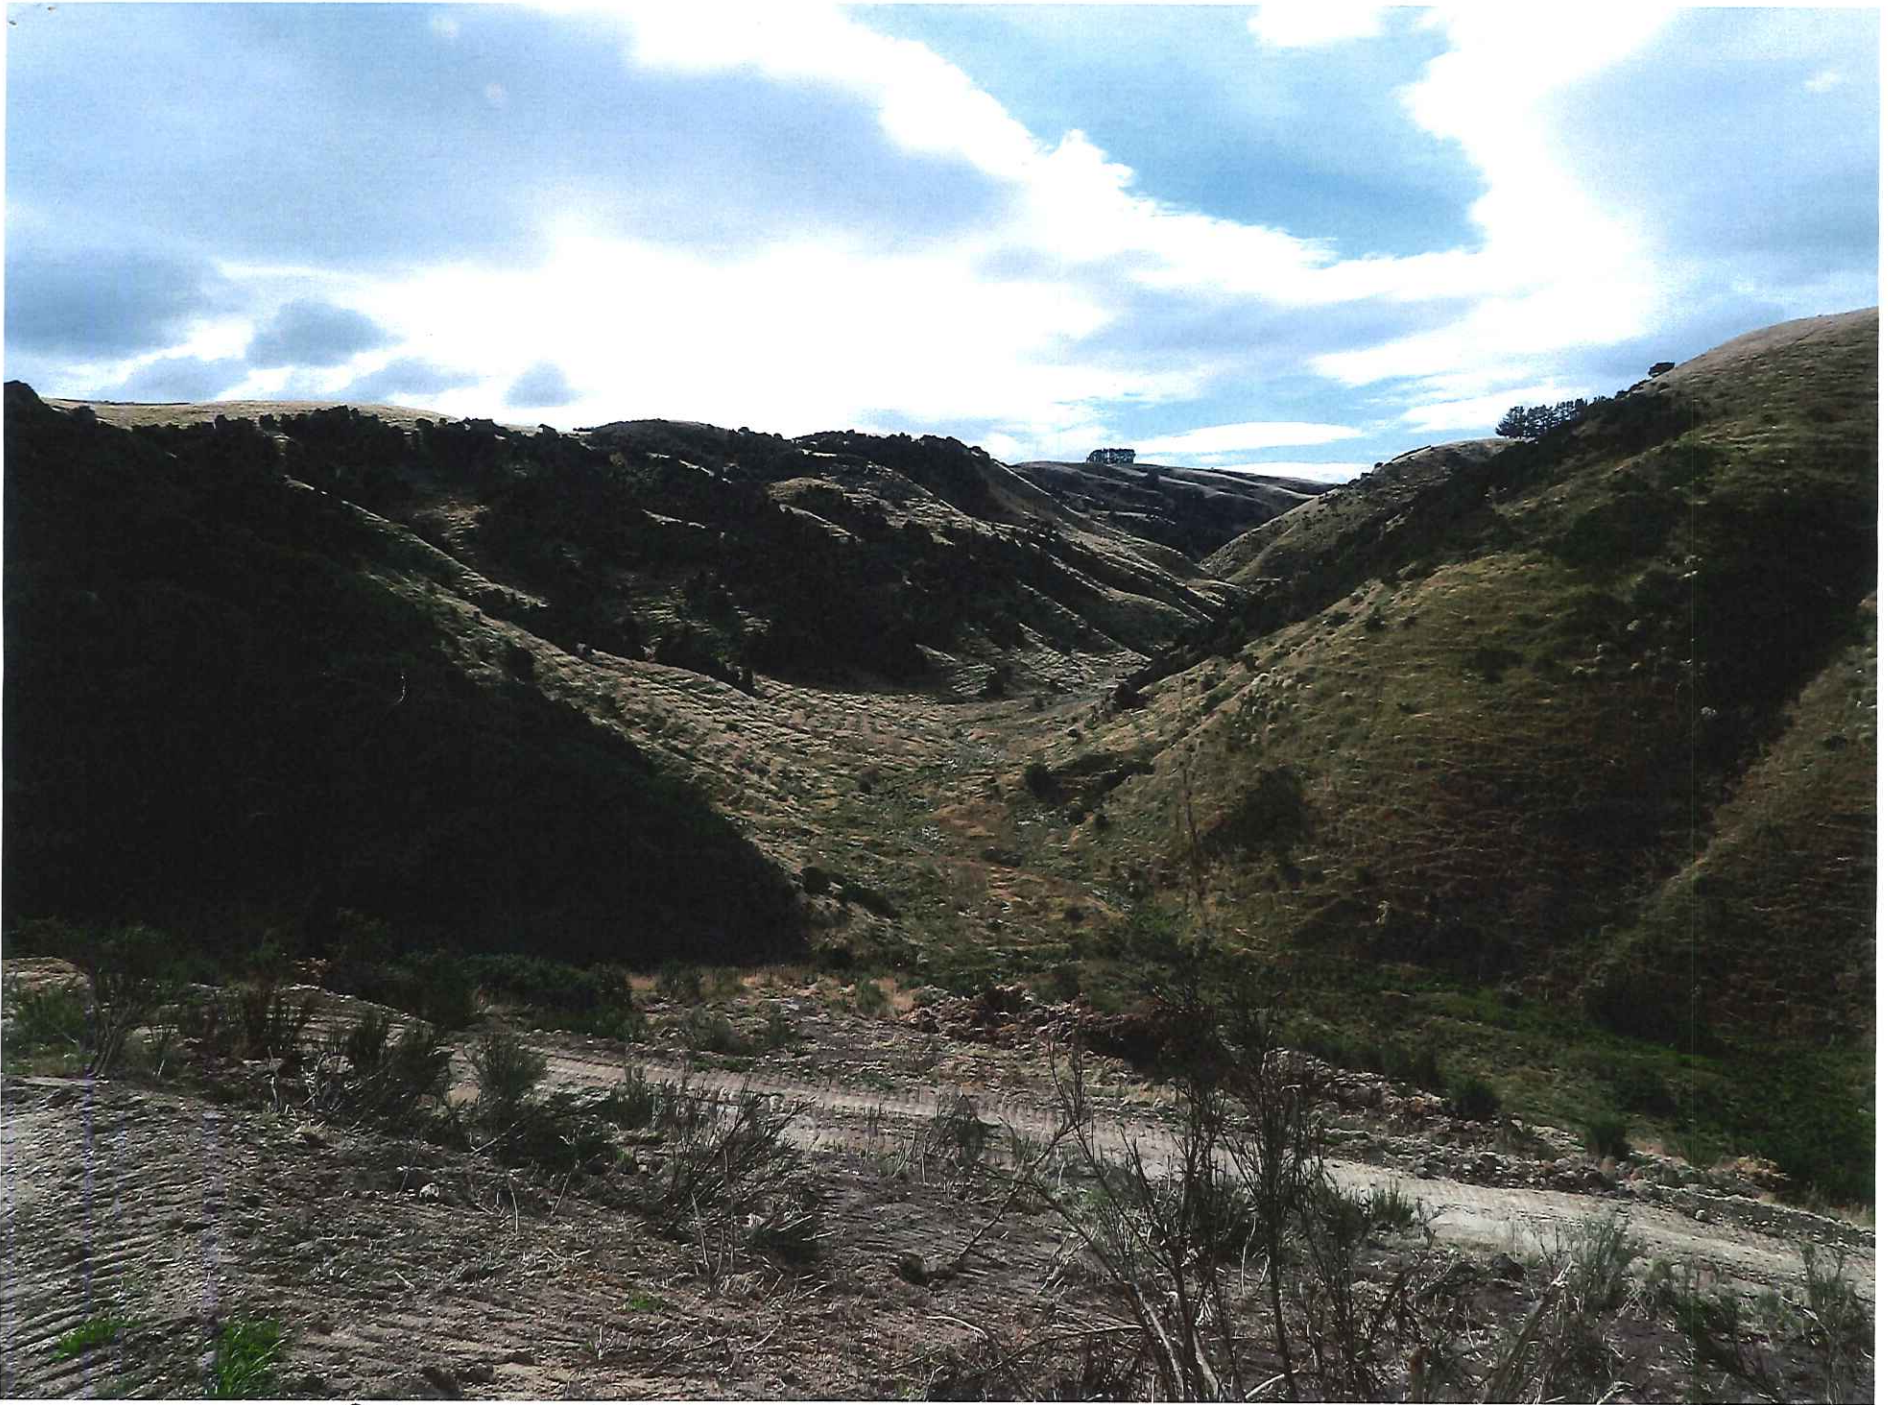
Same site after bulldozing + planting.
