Catherine Anderson  
~~0124~~ 963454

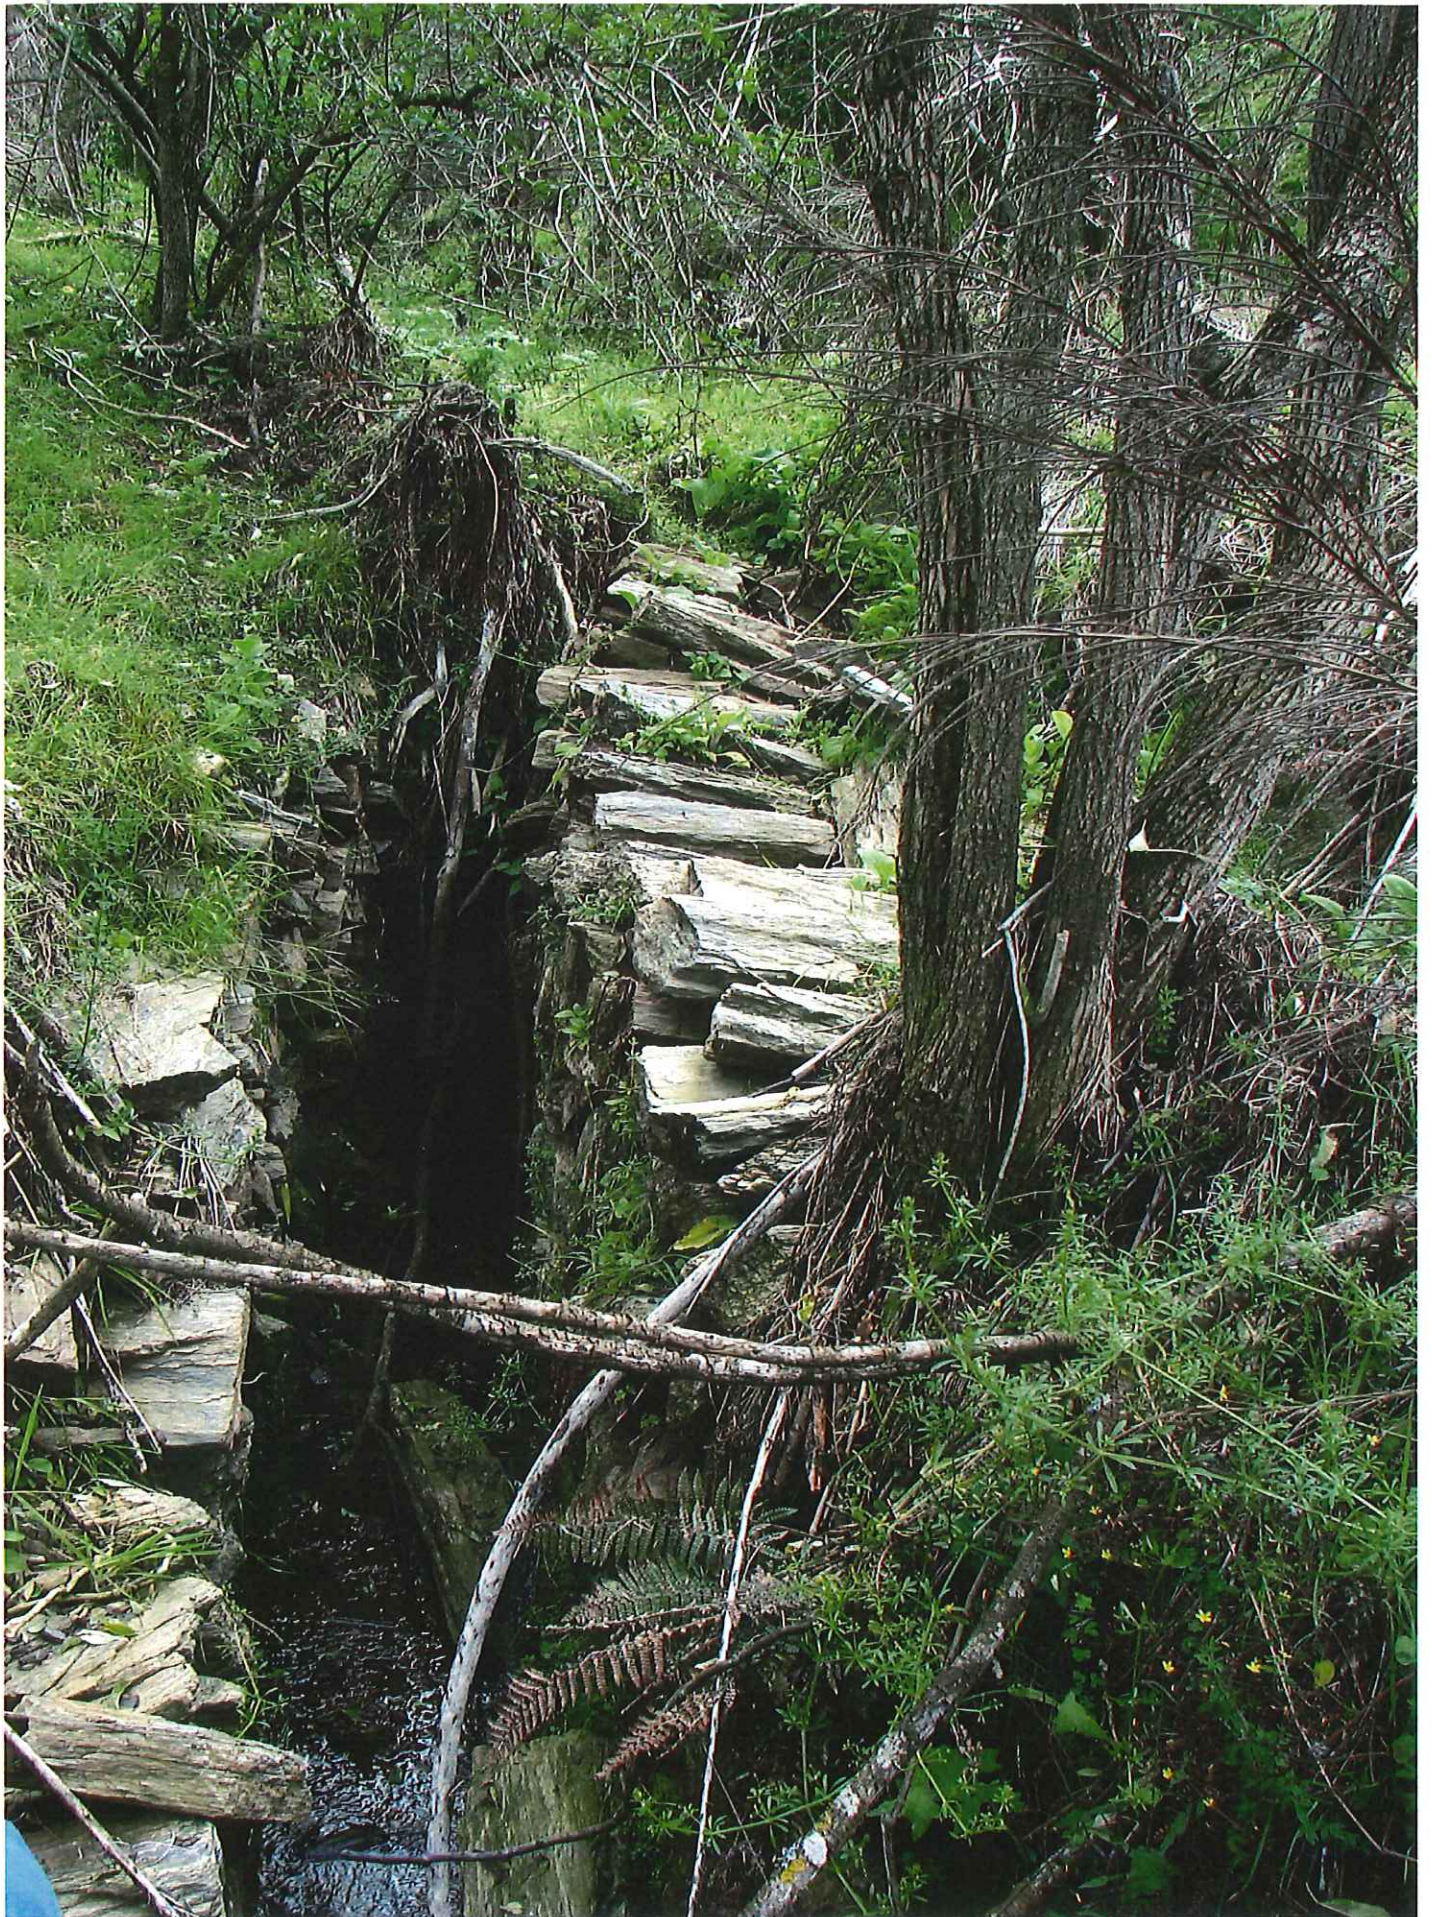
The water races that have been bulldozed over

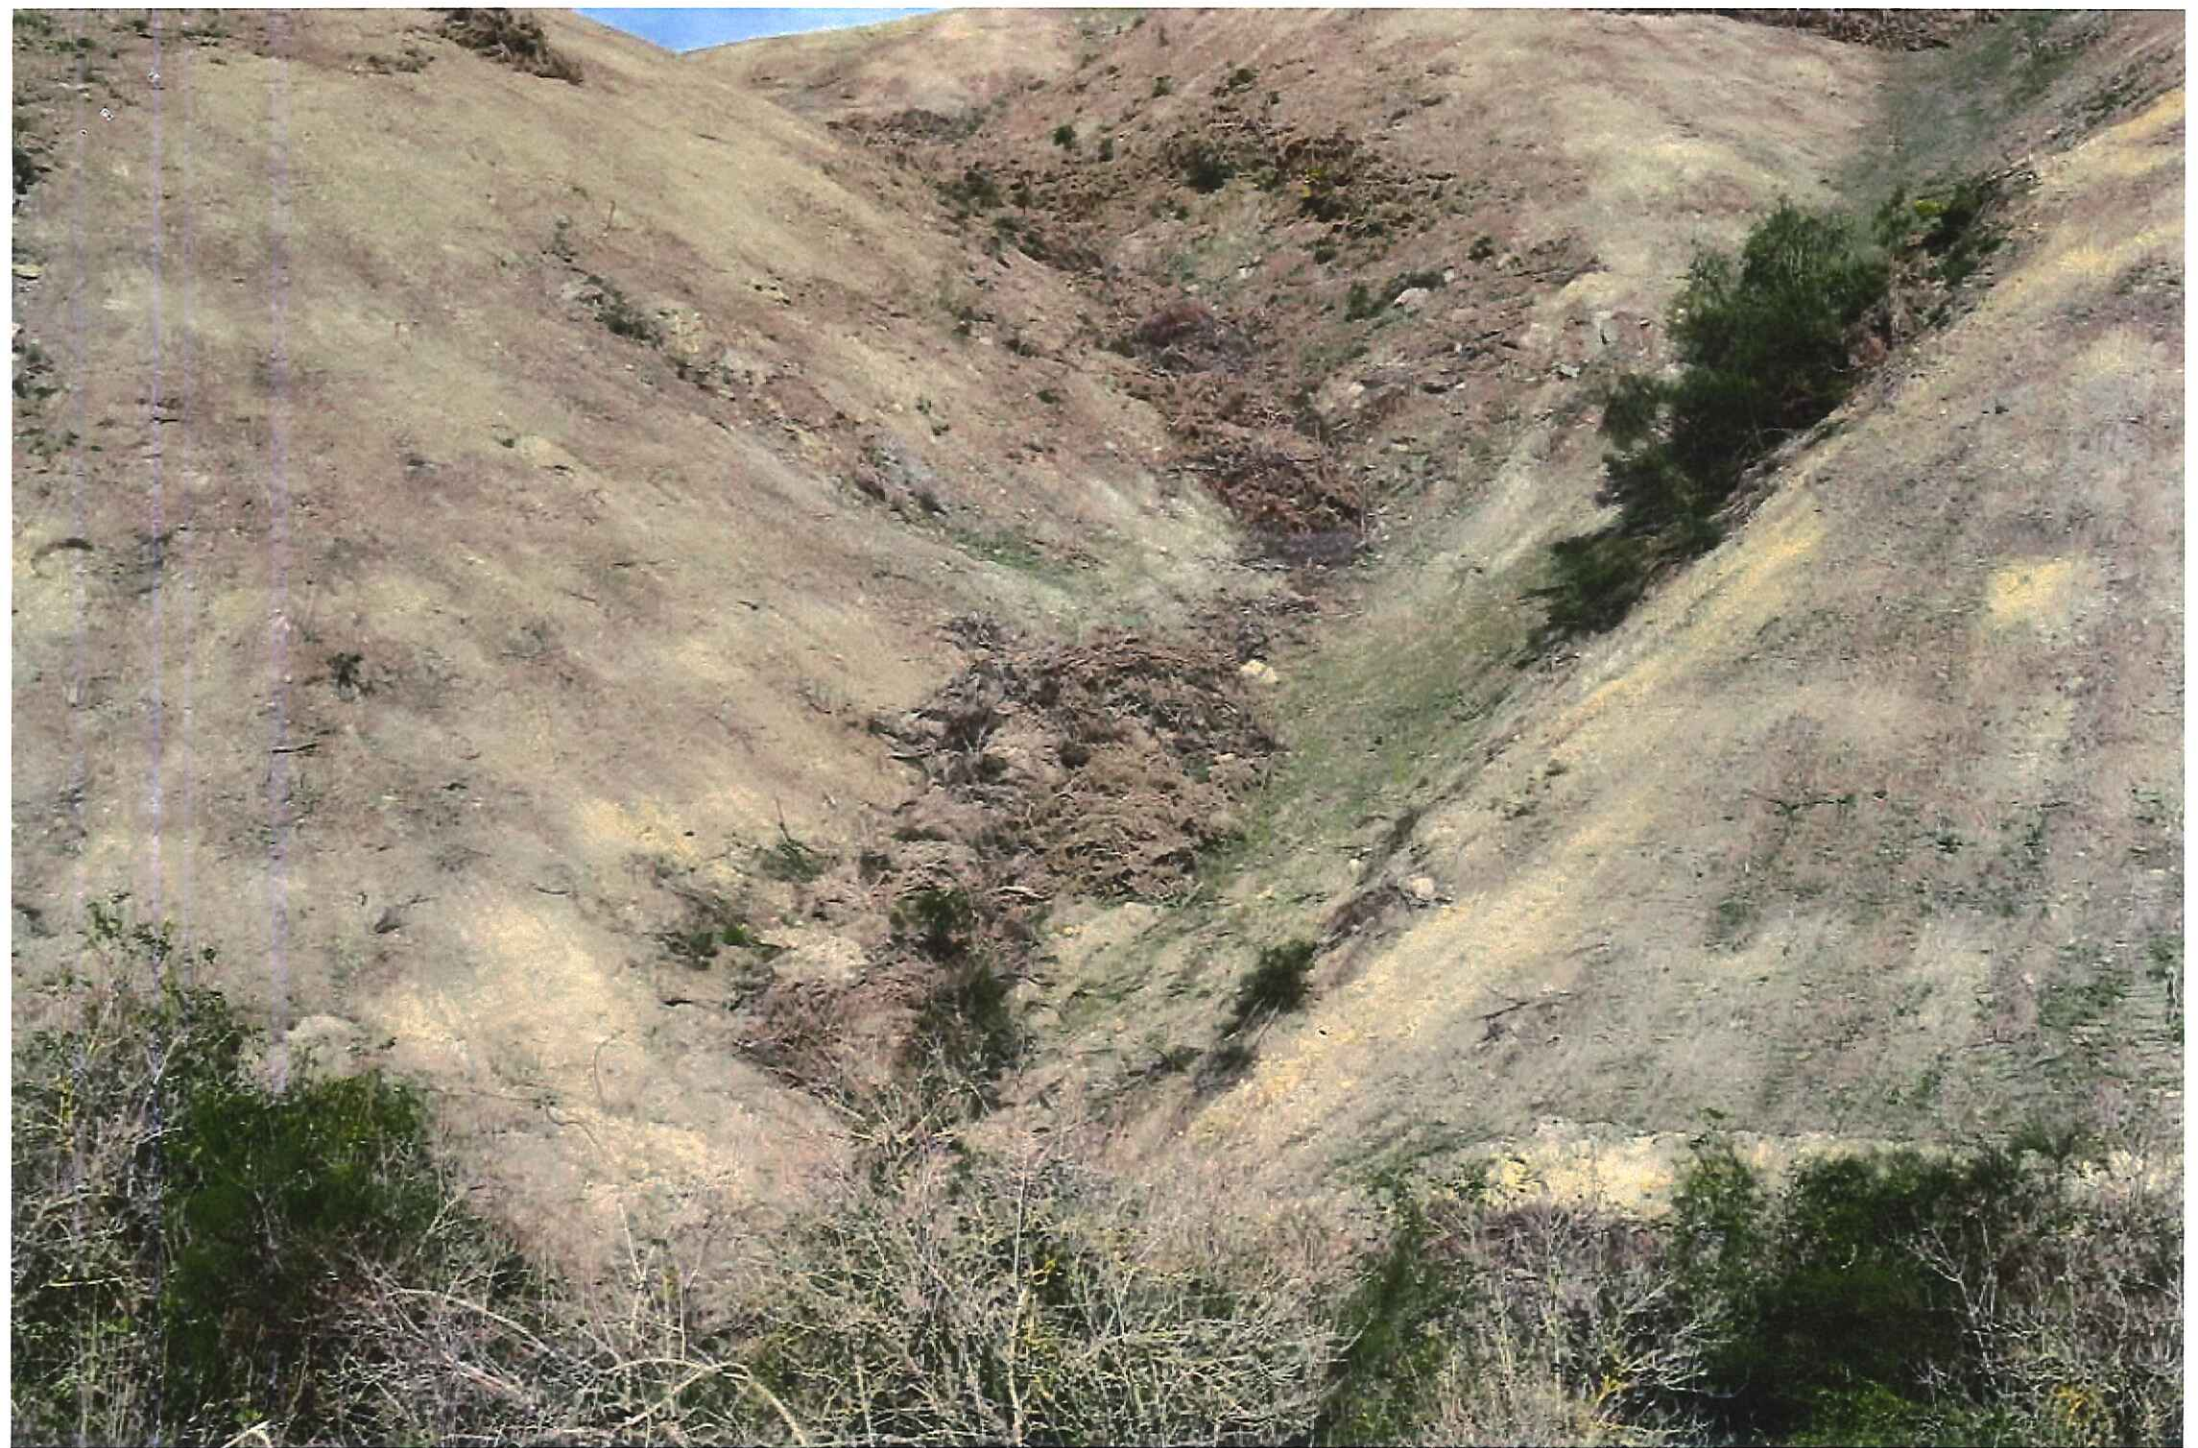
**Waterway**

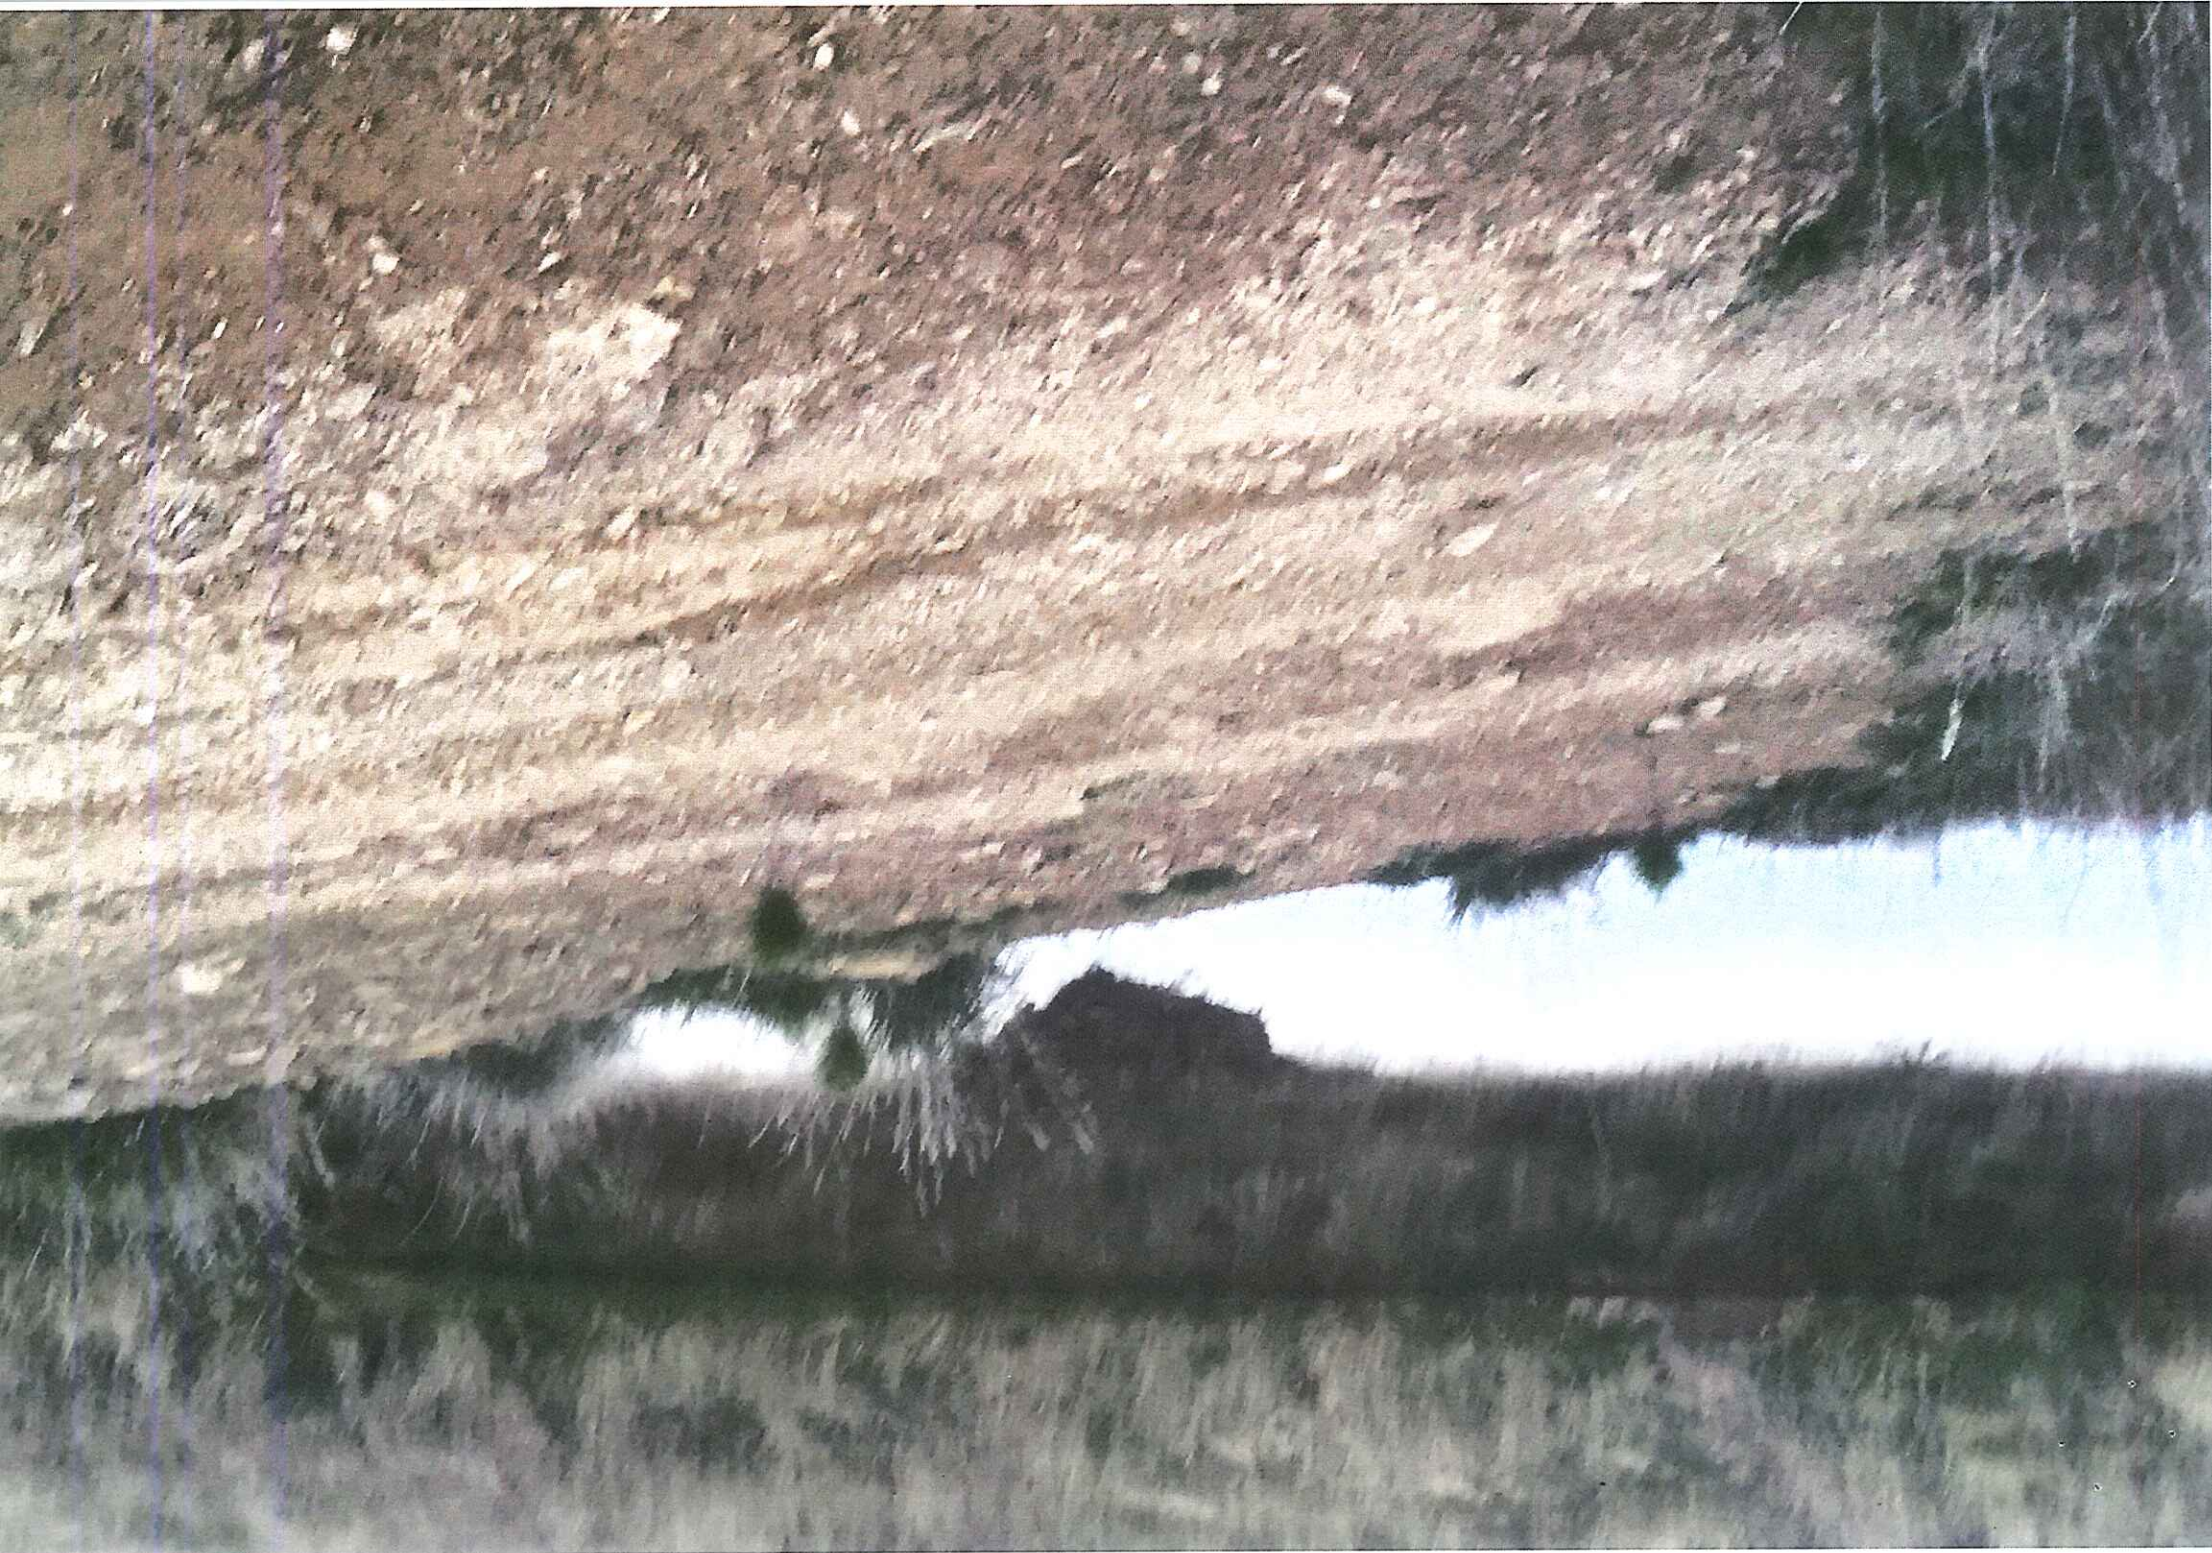
Water ways

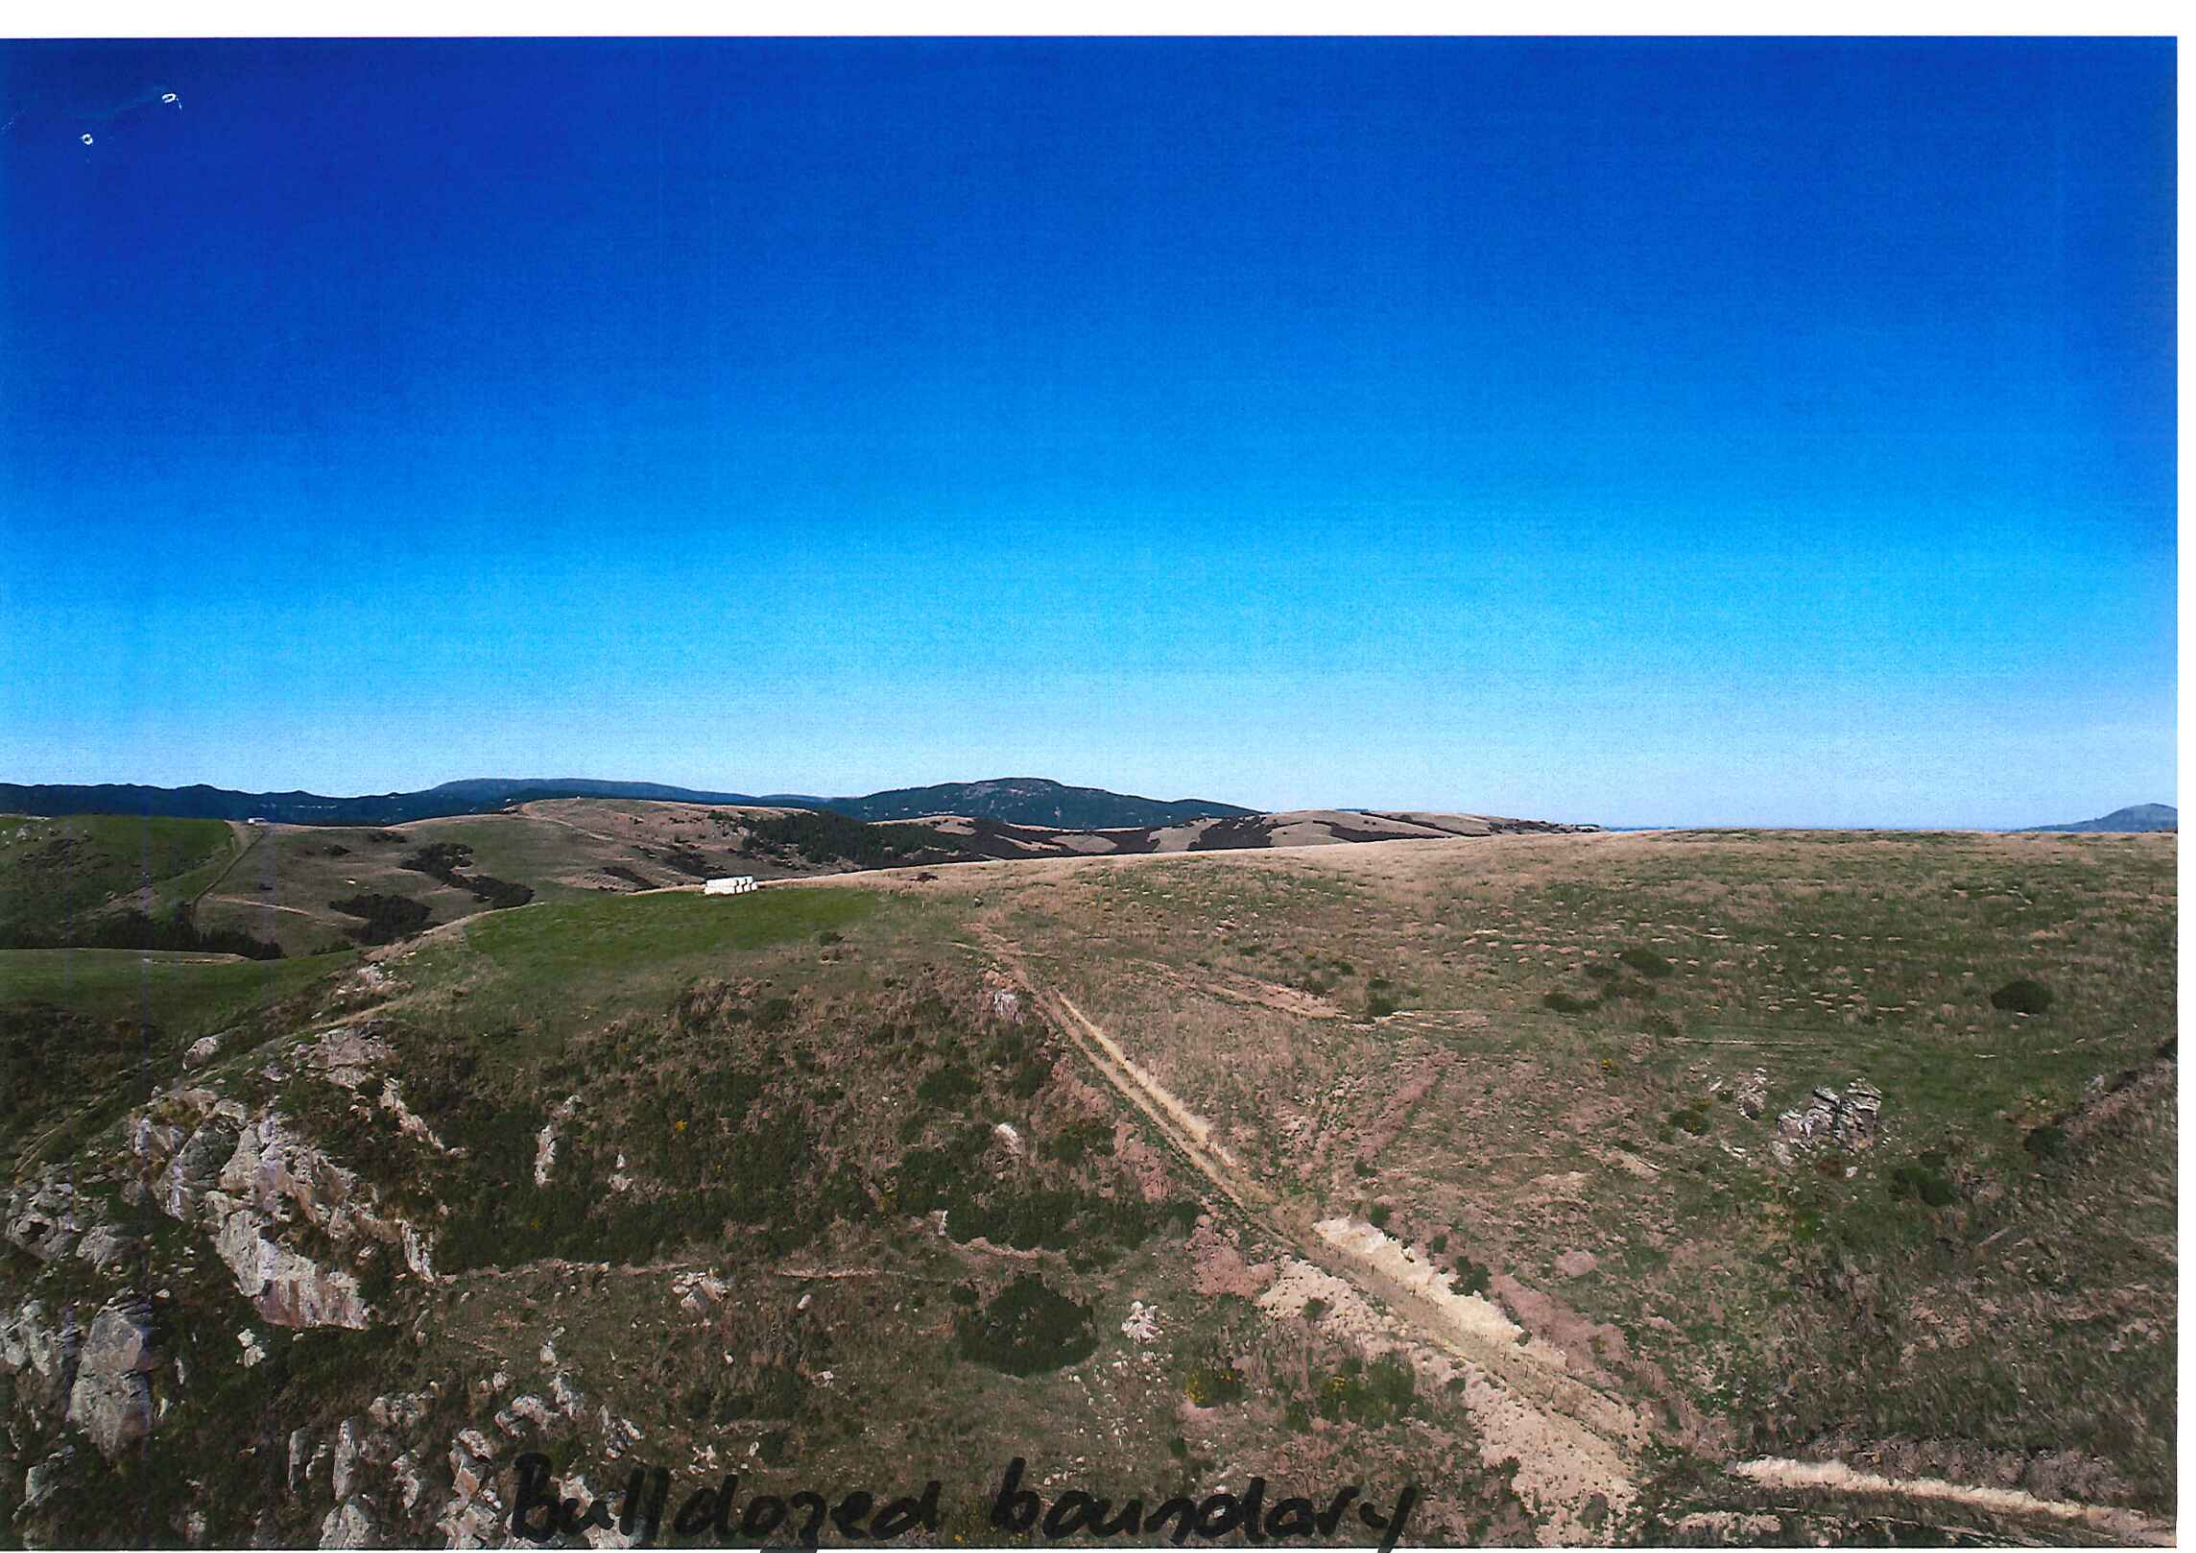
Bulldozed boundary

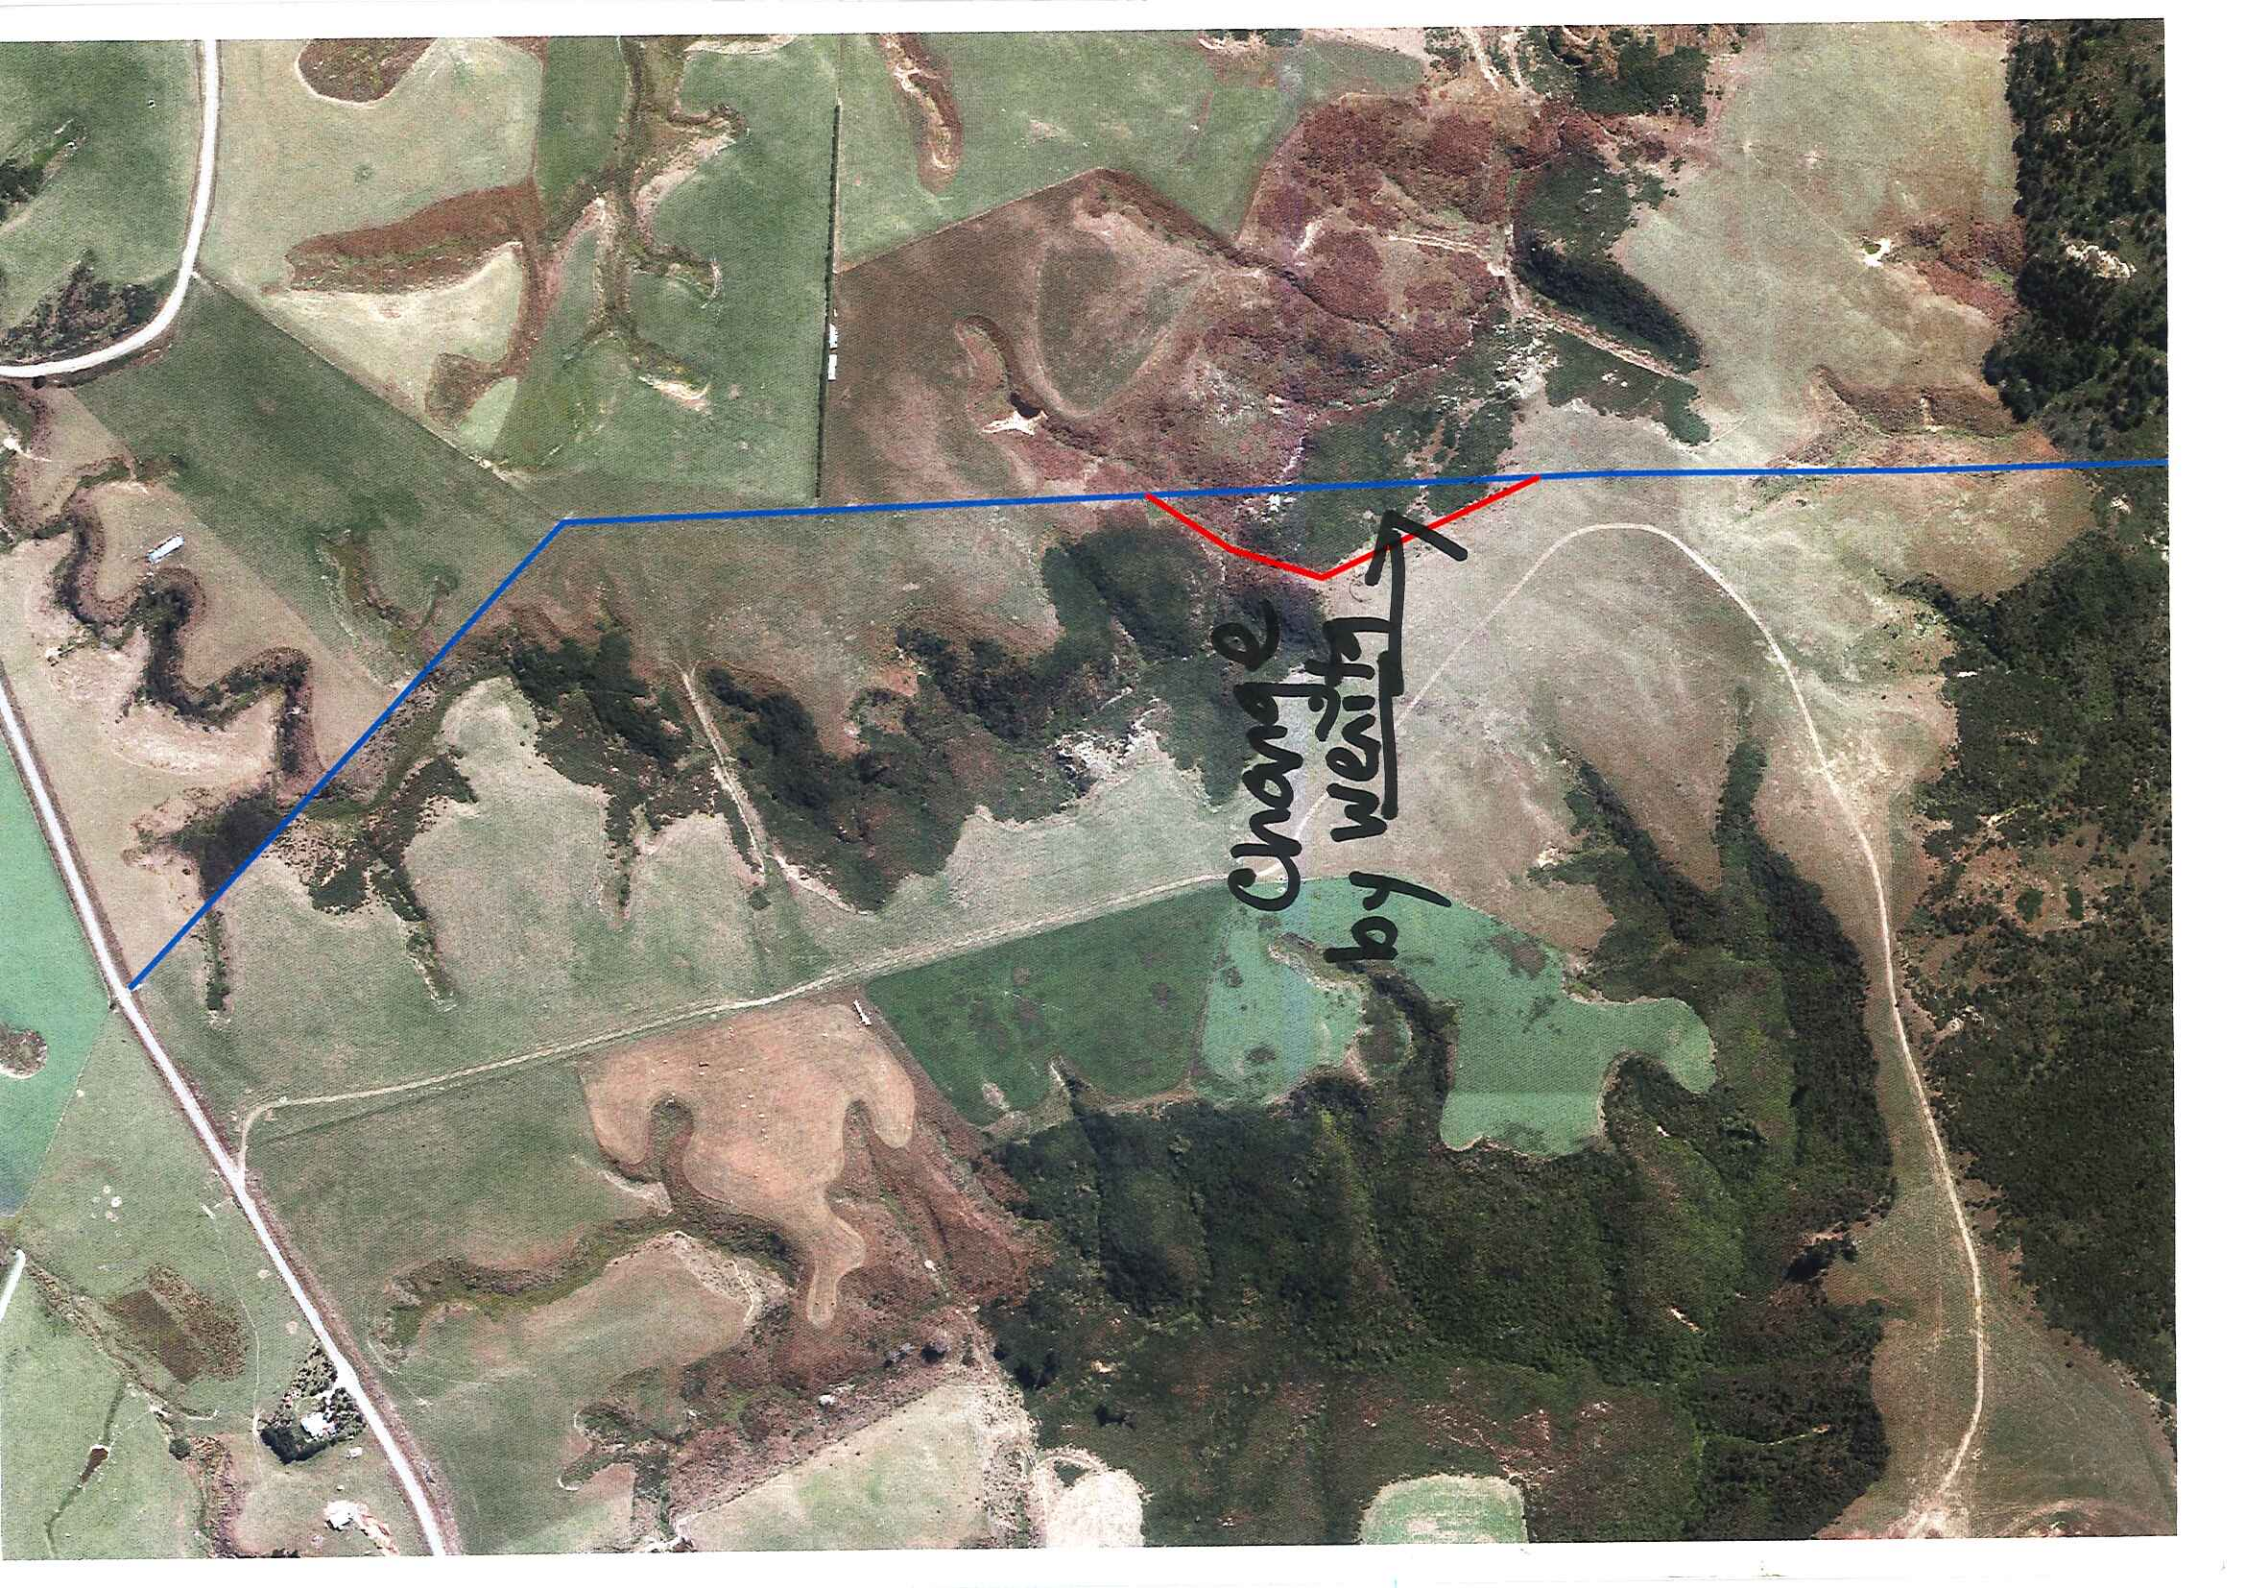
Change  
by wetlands

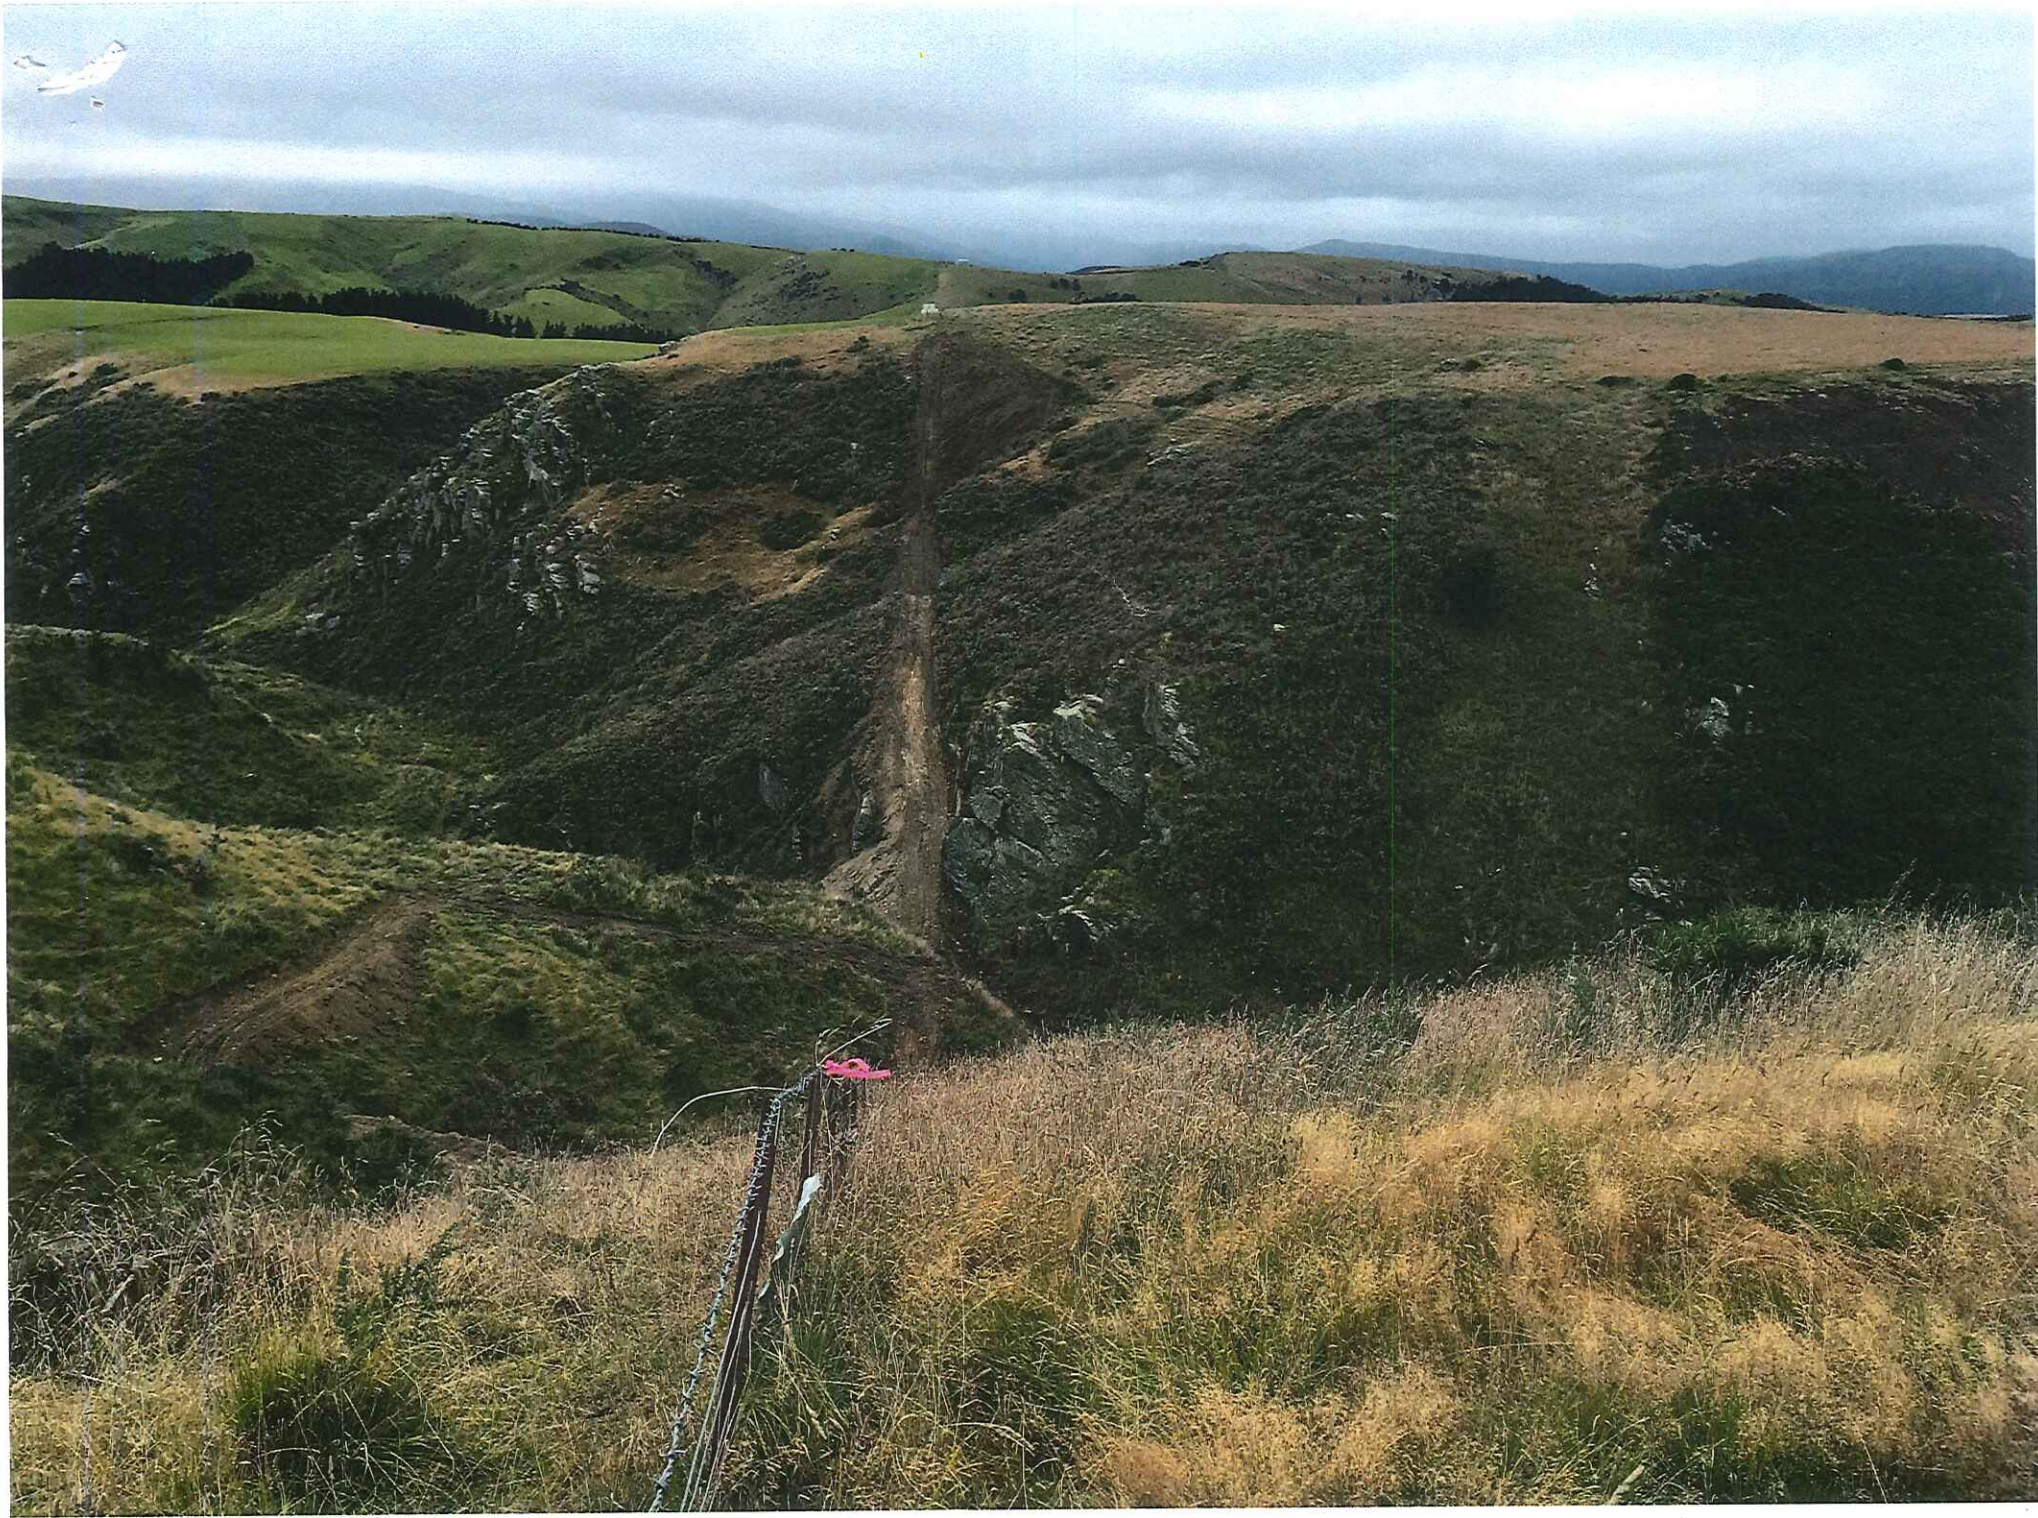
*Looking above bulldozer boundary.*

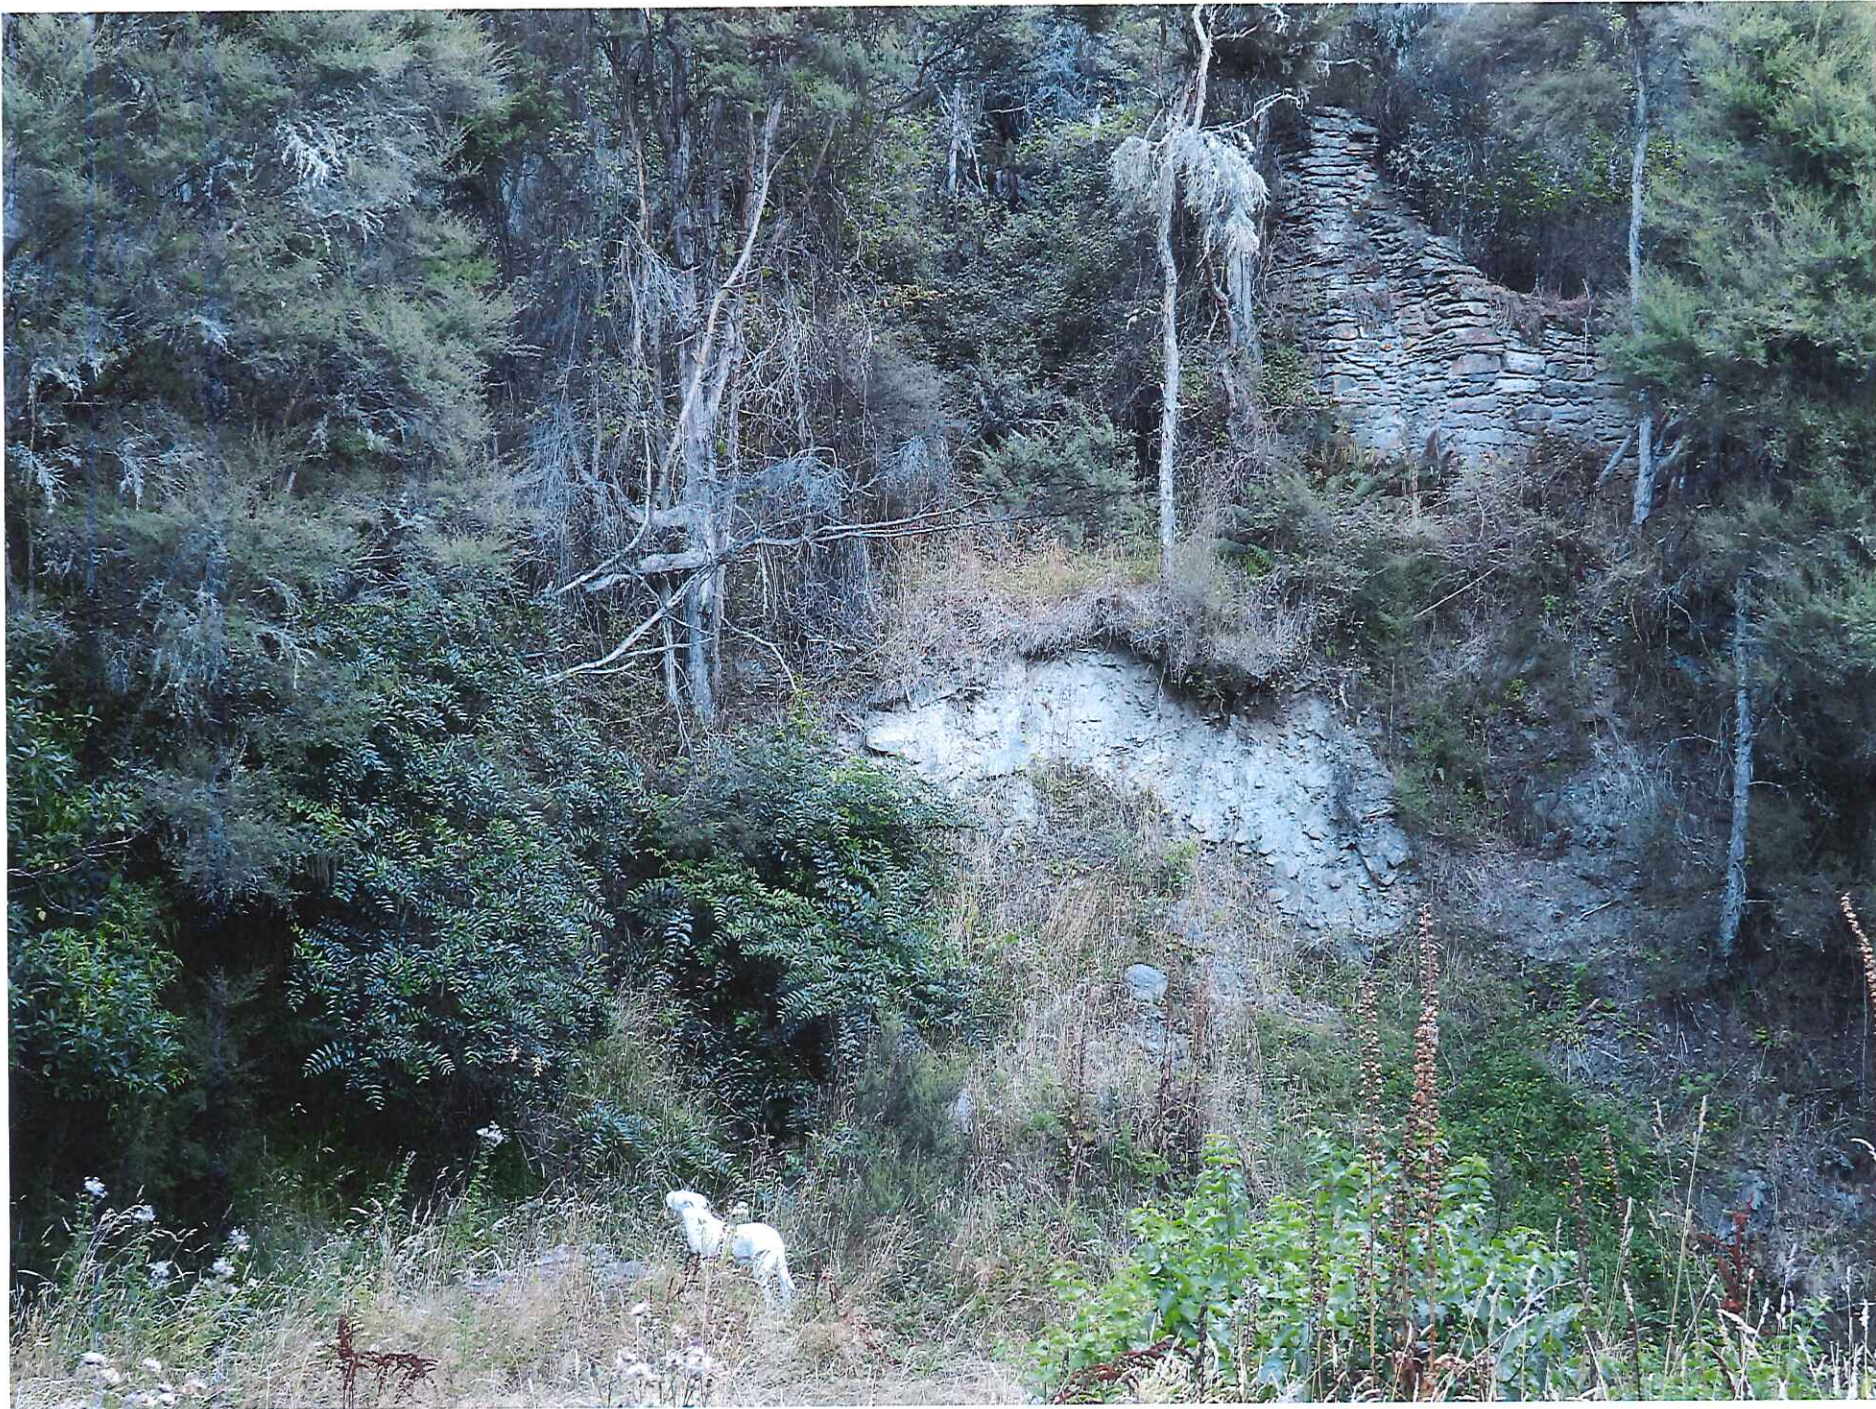
F Hut  
will  
be  
destroyed

This stone hut has a blocked waterway below.
