ARIZONA LEAGUE EROSION / BACKWASH CONCERNS

"Area of Significant Conservation Value"
District Plan

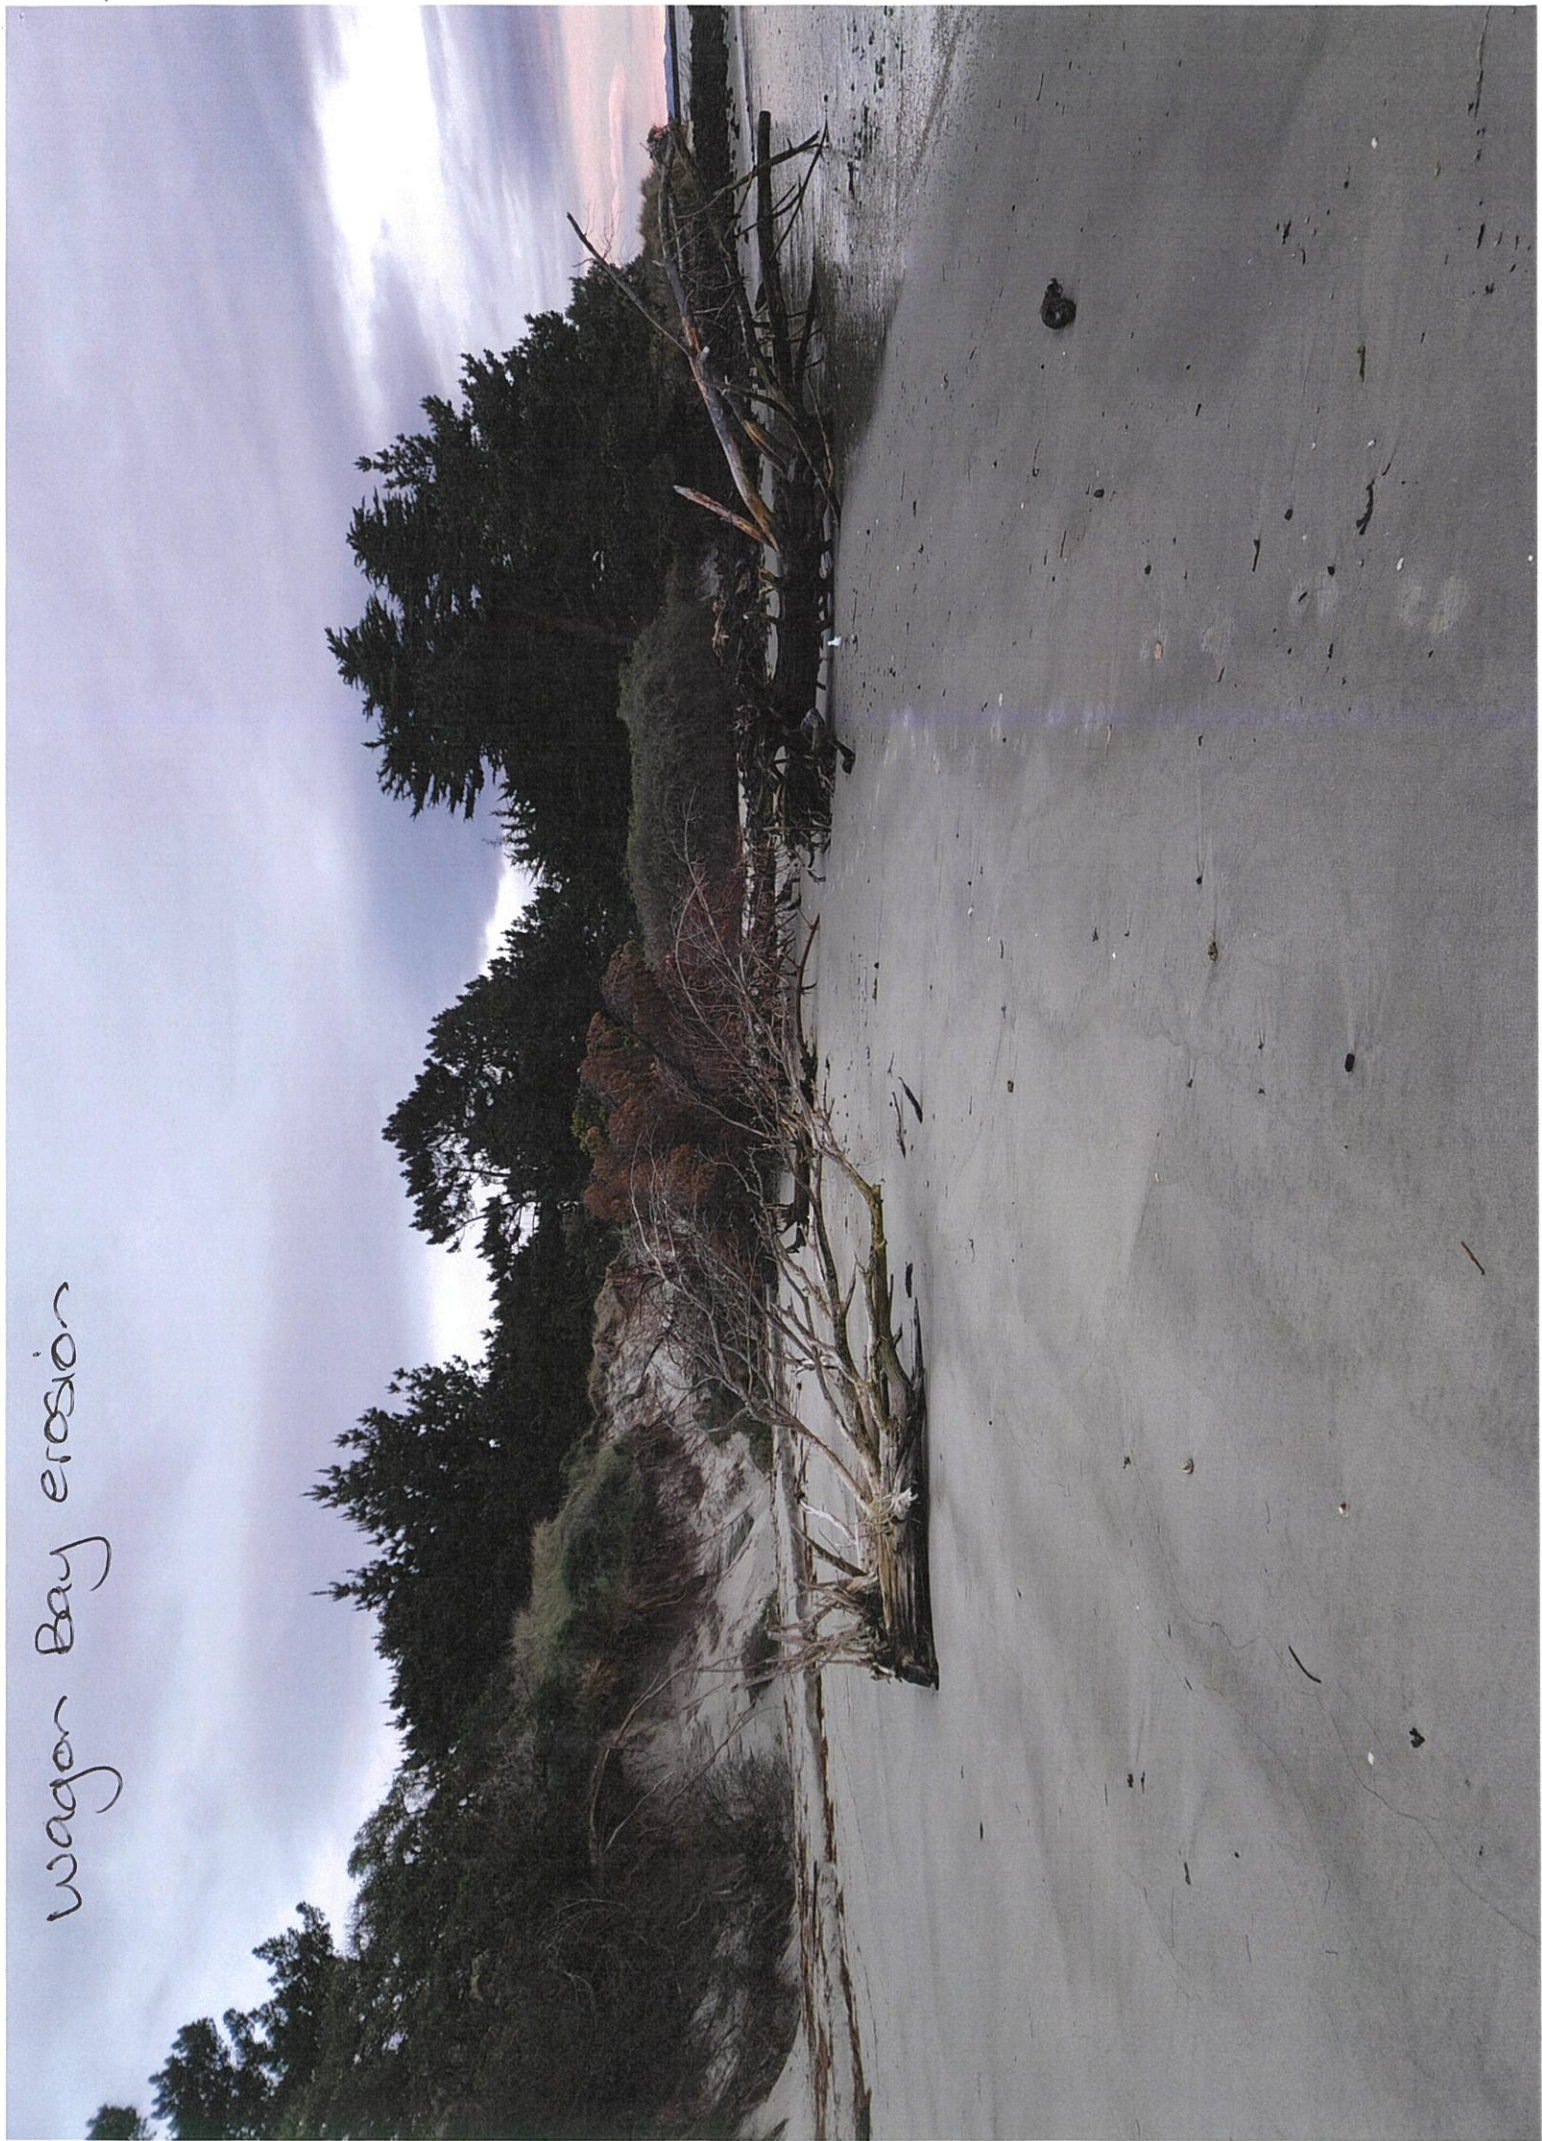
wagon Bay erosion

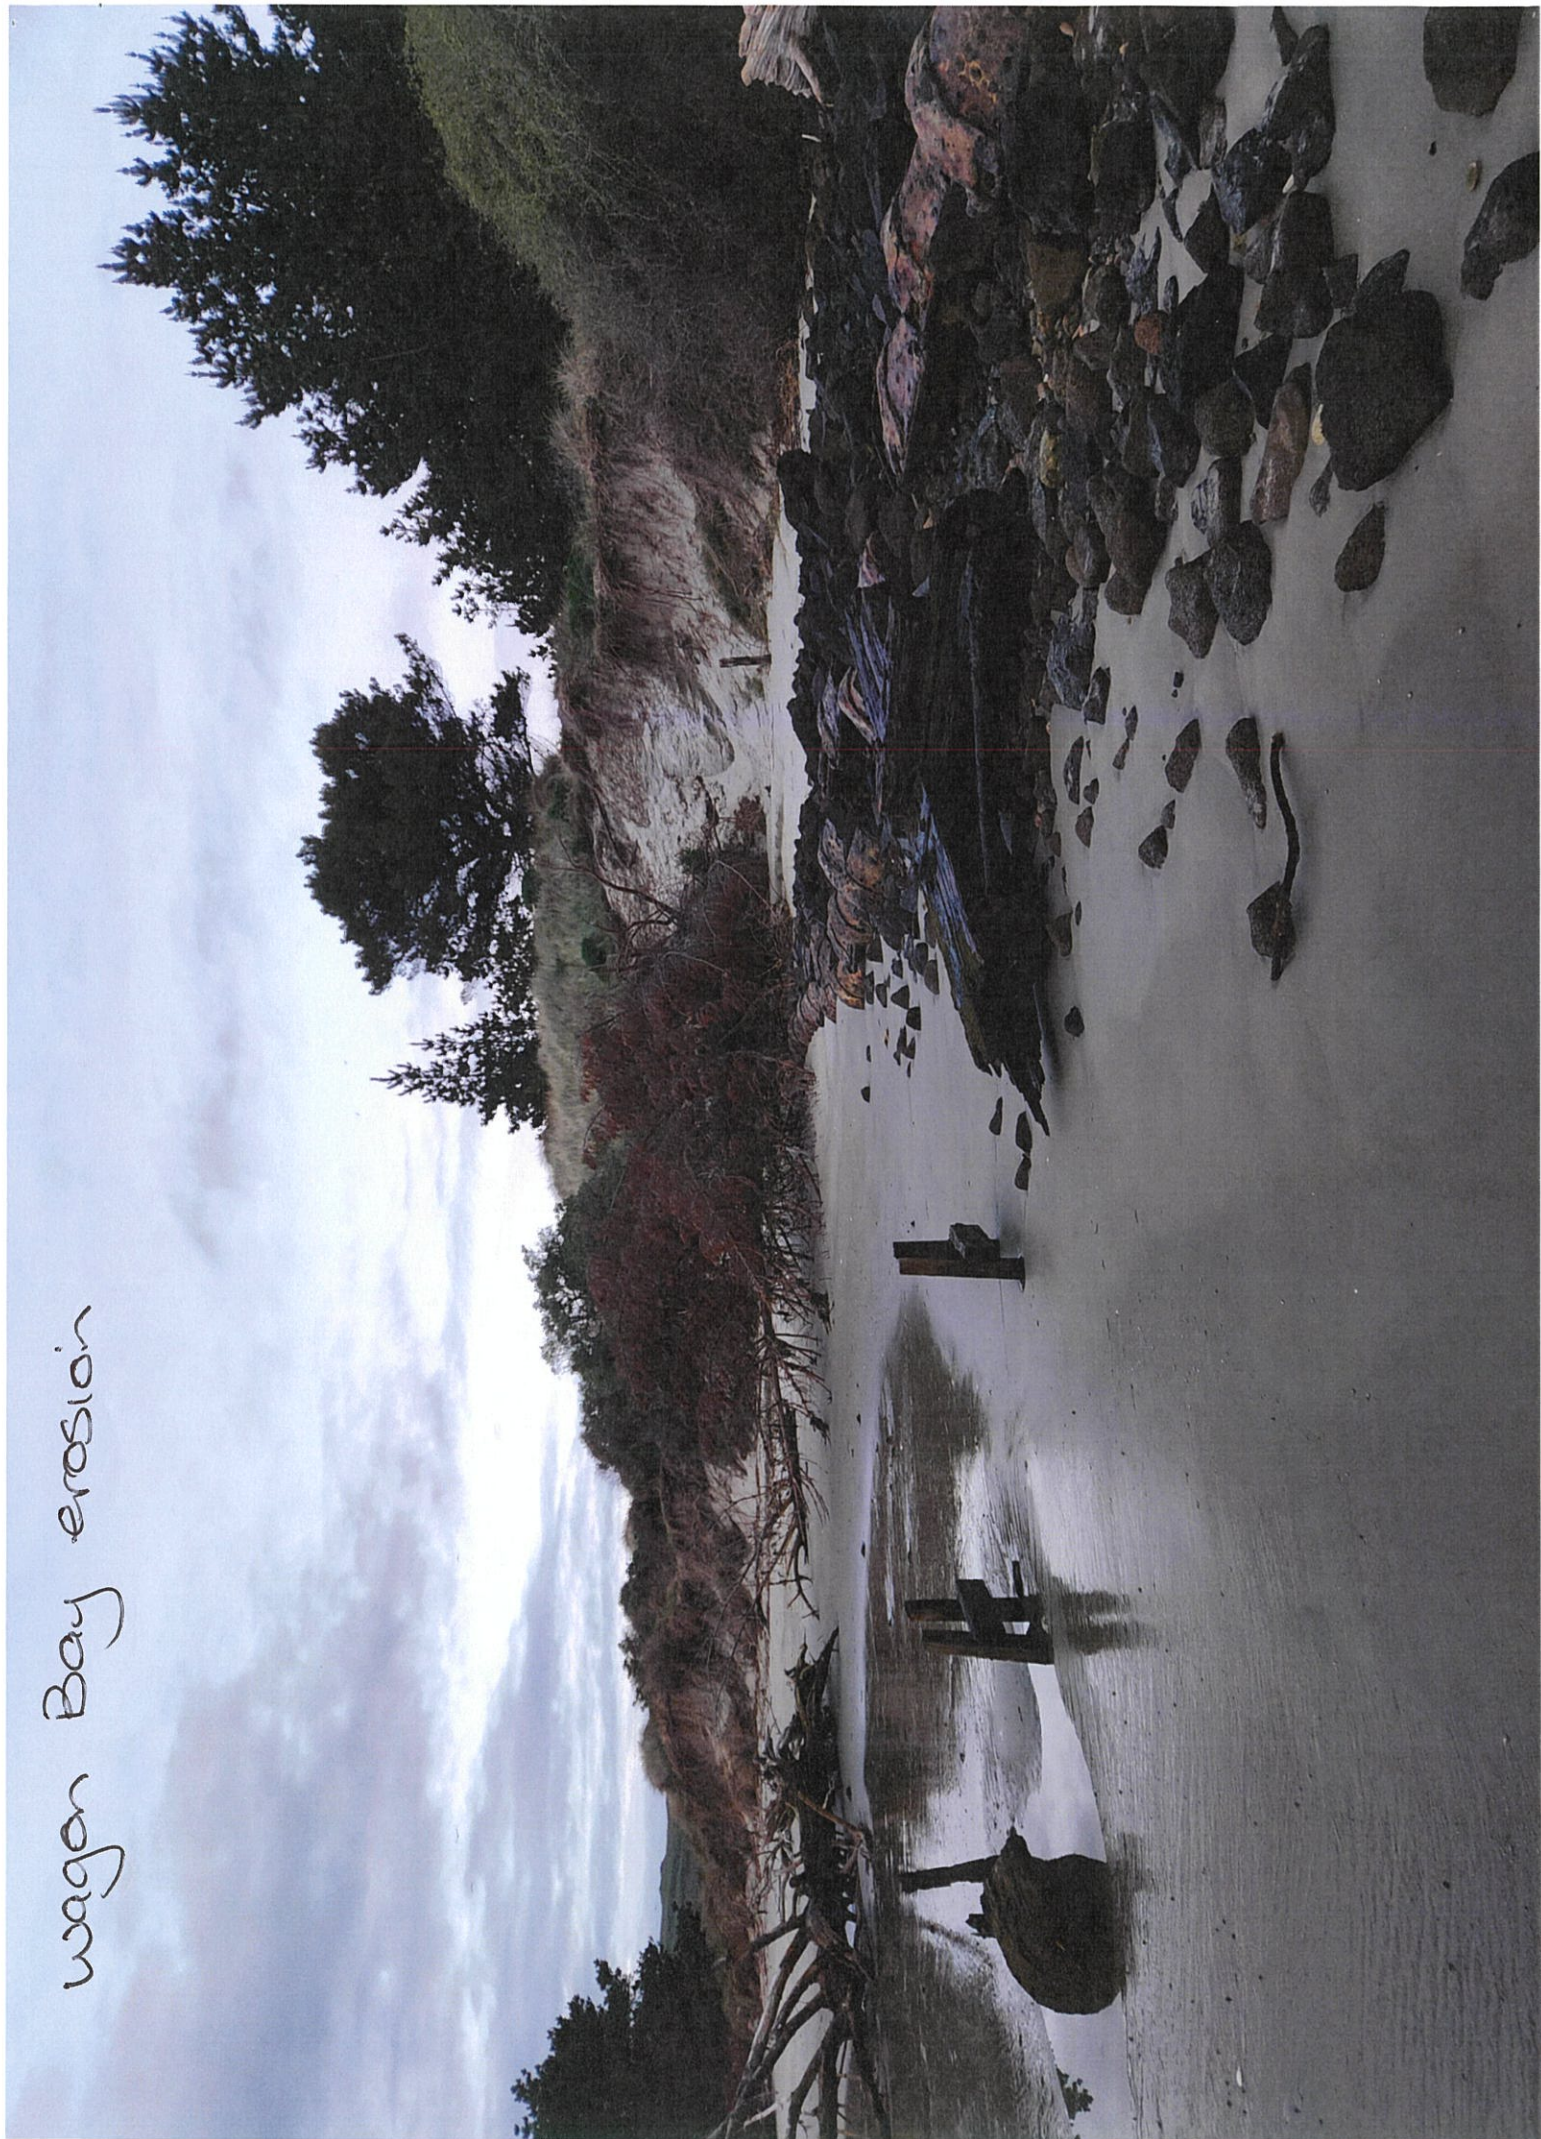
wagon Bay erosion

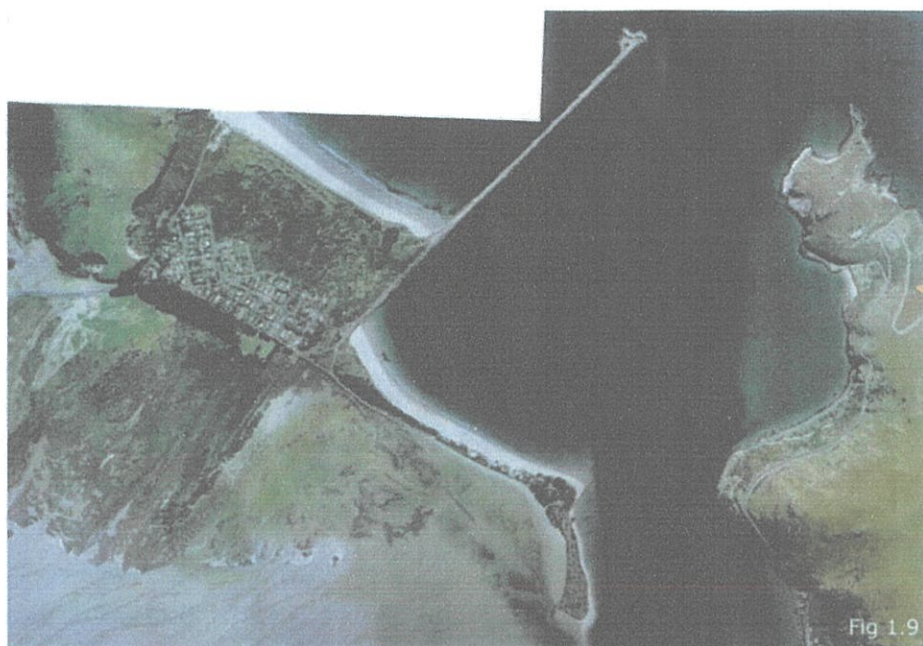
Figure 1.9 – Aerial photograph showing the Long Mac, together with several of the remnant secondary groynes

Sub
Groynes
x 3.?

The most northerly structure remains evident today, refer Figure 1.9, and appears to have been constructed to a similar height as the Long Mac. The figure clearly shows the build-up of sediment that has occurred on the upstream, or Shelly Beach side of this secondary groyne. Several, largely sand covered rubble mounds are also evident further along "The Spit" toward the jetty.

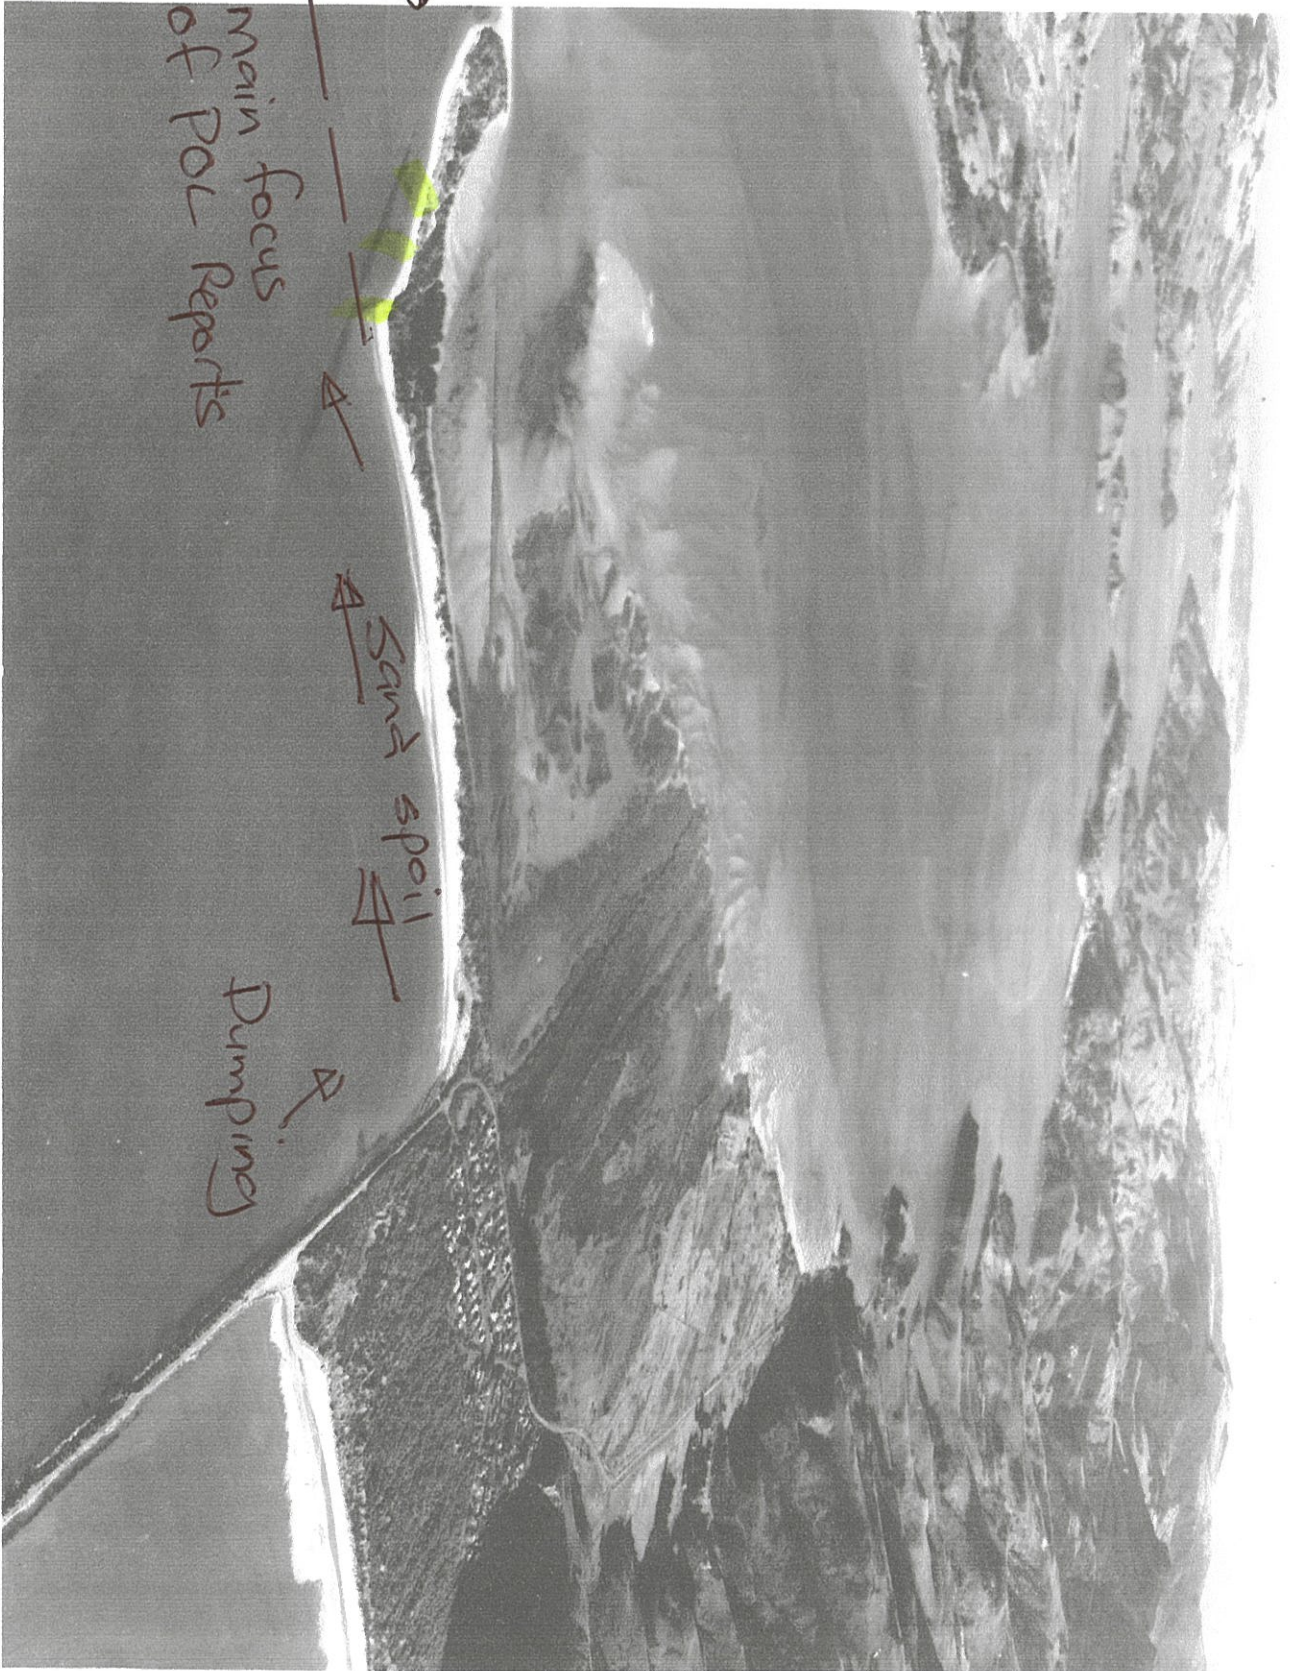
Sub groynes
never
maintained

POL: maintain existing assets ie long mac entire groyne system
Dunes created by OTHB (Otago Harbour Board)
now POL need to protect by maintaining groynes.

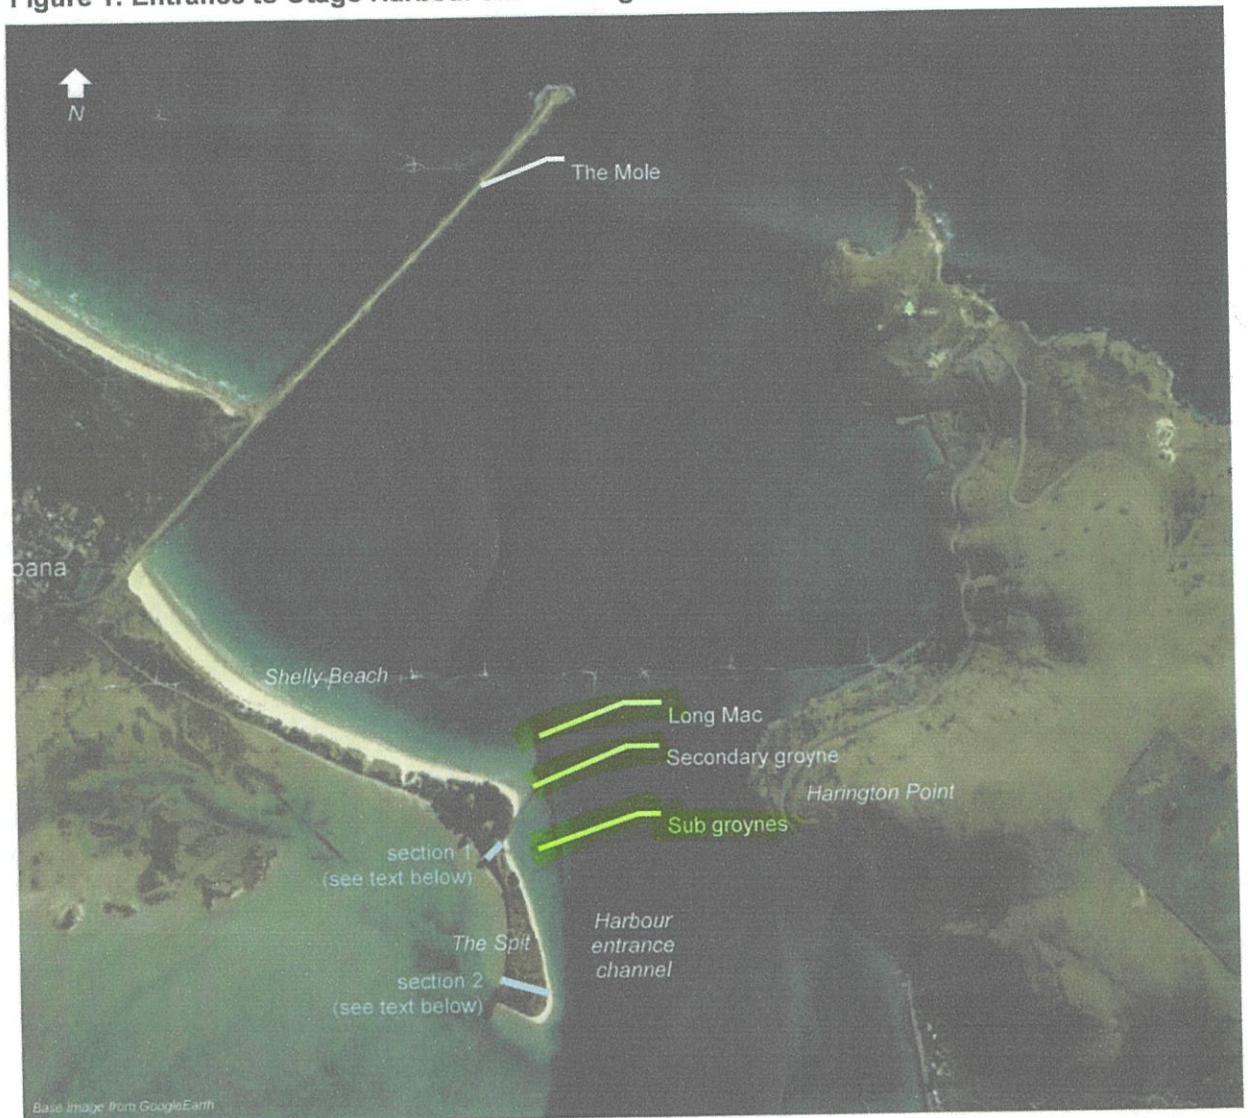
Figure 1: Entrance to Otago Harbour and training structures

- Aerial photographs indicate of the order of 10m reduction in the width of the Spit at the northern end (section 1 in Figure 1) and of the order of 5m at the southern end (section 2 in Figure 1), over the past 12 years. From reports and anecdotal information, it appears that the shoreline of the Spit has periodically accreted and eroded. This does not appear to notably affect the functioning of the Long Mac itself. The landward extent of the secondary (northernmost) groyne is not documented and outflanking is not been recorded in the literature available, however it may be prudent to monitor any potential for this over time.
